Over the last 18 months, an independent team of scientists and engineers with expertise in coastal restoration has worked to prepare the attached report on Sharp Park, *Conceptual Ecosystem Restoration Plan and Feasibility Assessment: Laguna Salada, Pacifica, California*.

Prepared for:

Wild Equity Institute
Center for Biological Diversity

ESA PWA

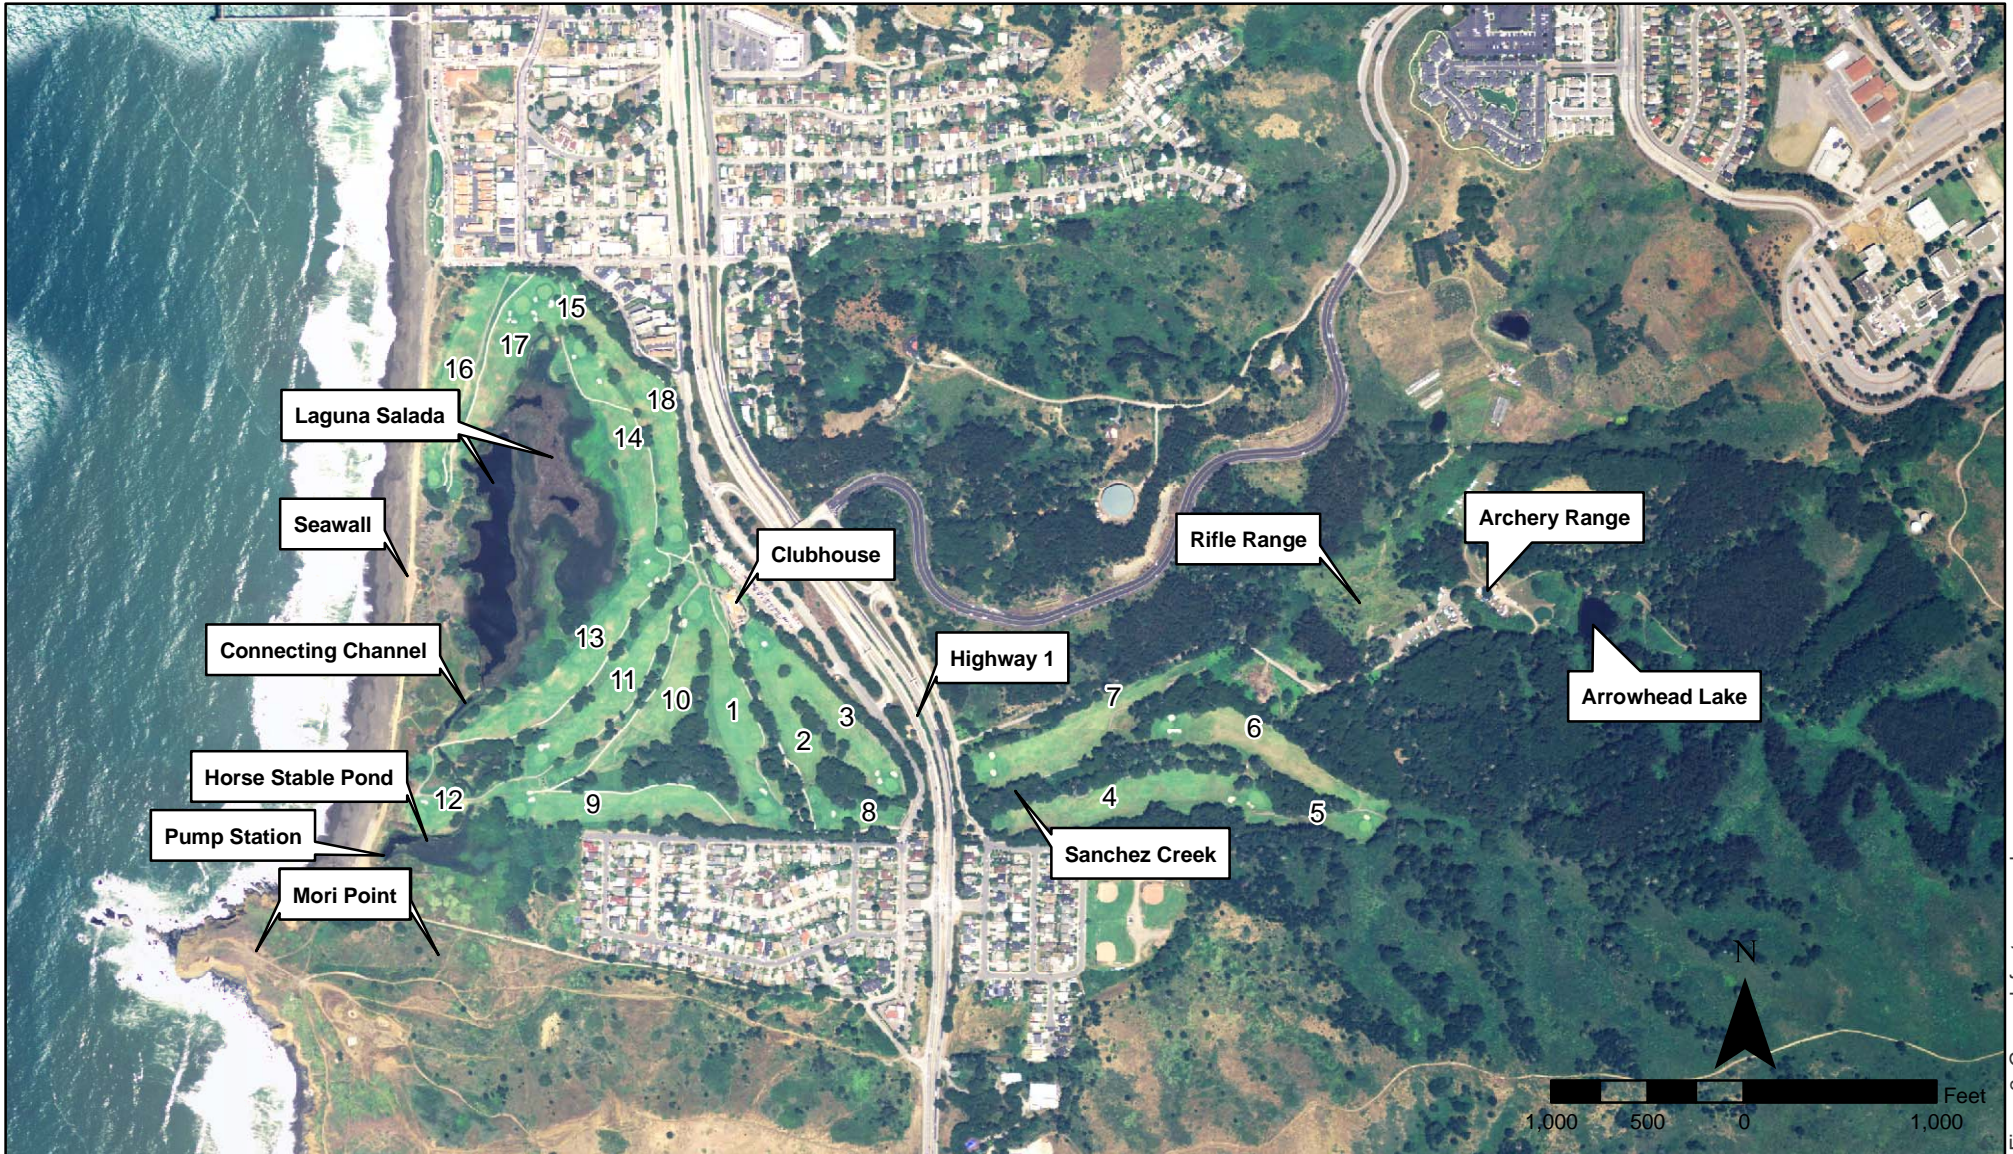
Figure 2

Sharp Park General Features

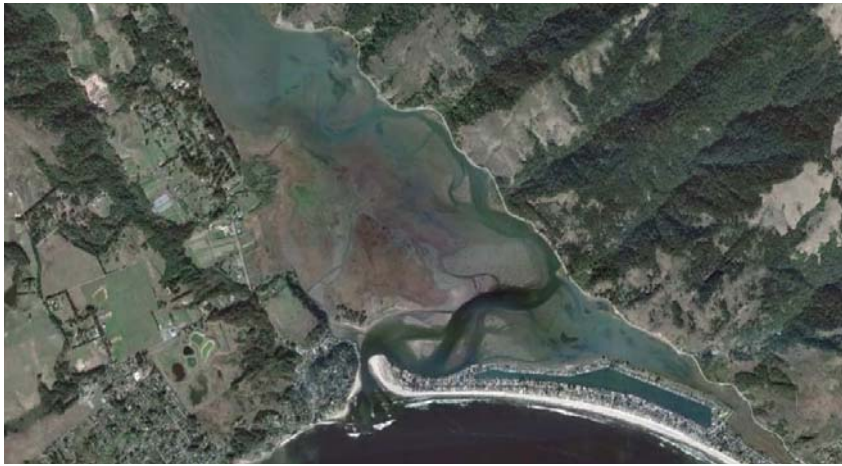
a) Example tidal lagoon – Bolinas Lagoon, Marin County, CA

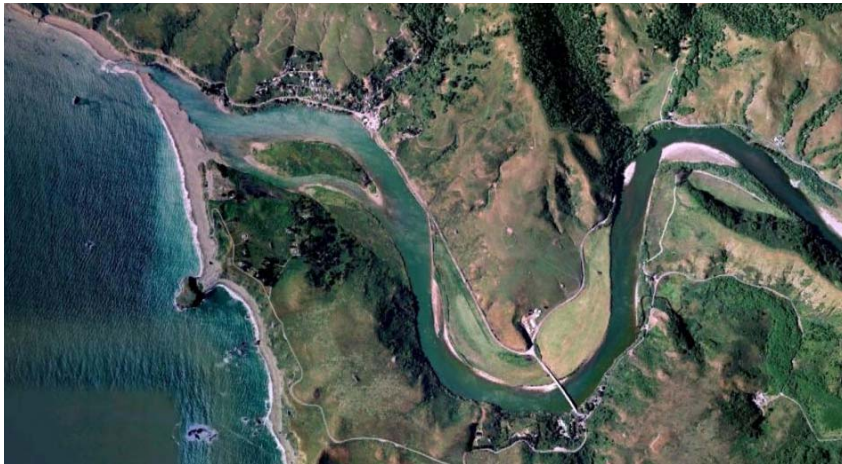
b) Example seasonal lagoon/estuary – Russian River, Sonoma County, CA

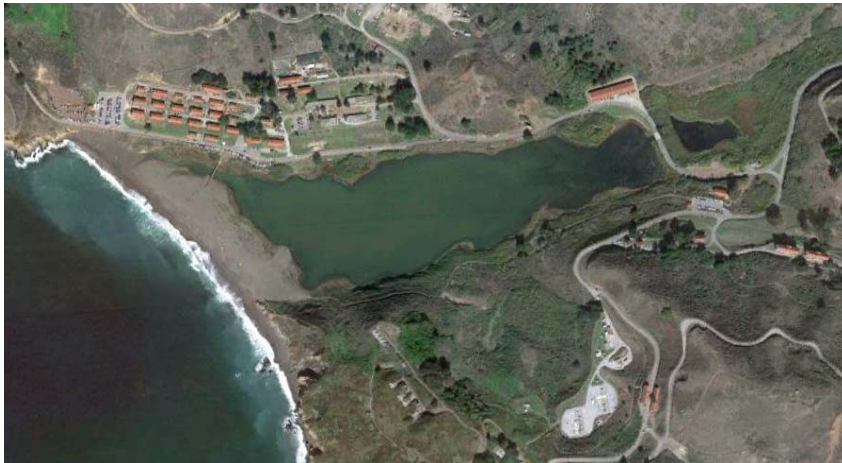
c) Example non-tidal lagoon – Rodeo Lagoon, Marin County, CA

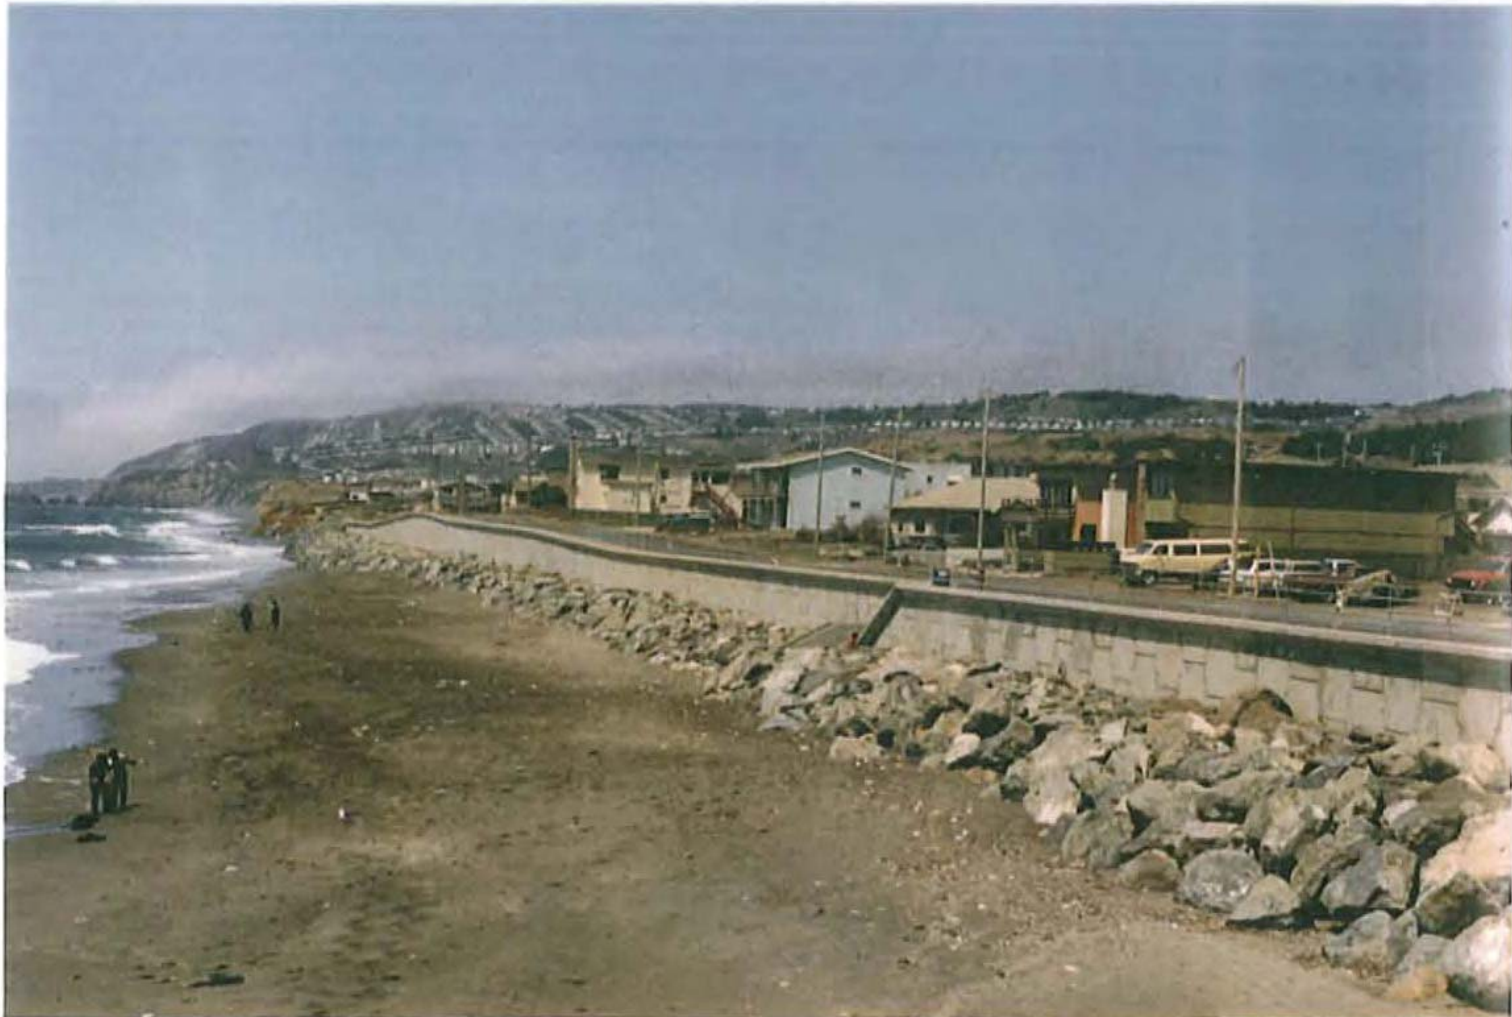
Source: Geomatrix (1987) Photograph 6. Caption: Recently constructed reinforced earth seawall with armor stone toe protection. This wall extends along Beach Boulevard north of the Fishing Pier in Pacifica (August 1985).

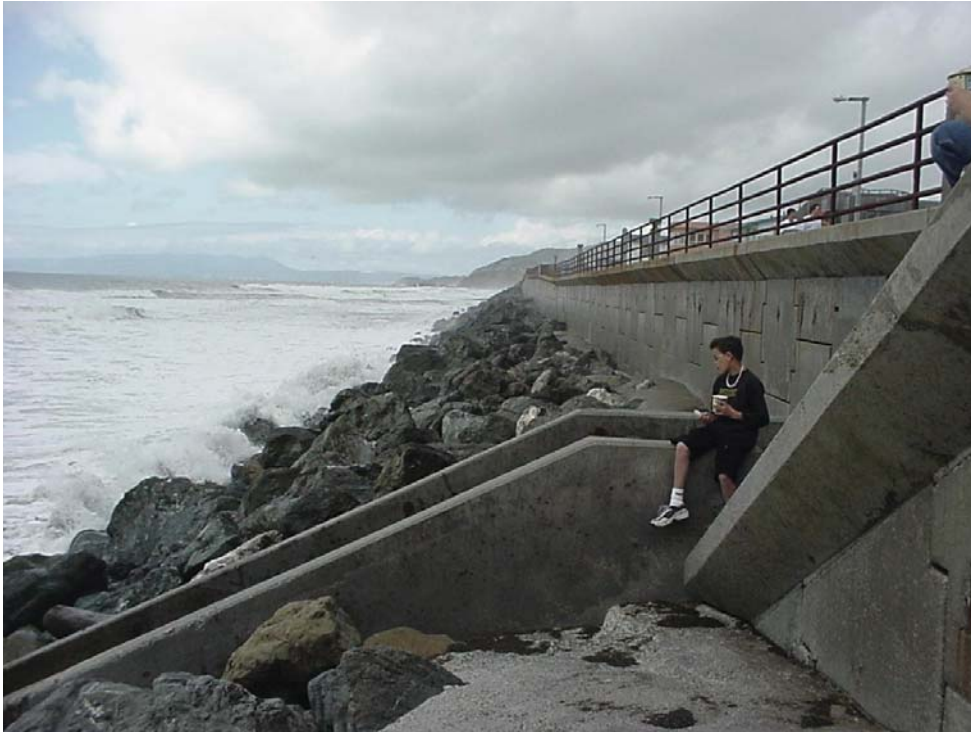
(b) Sharp Park Seawall about 20 years after construction, with no beach at high tide.
Typical Winter conditions

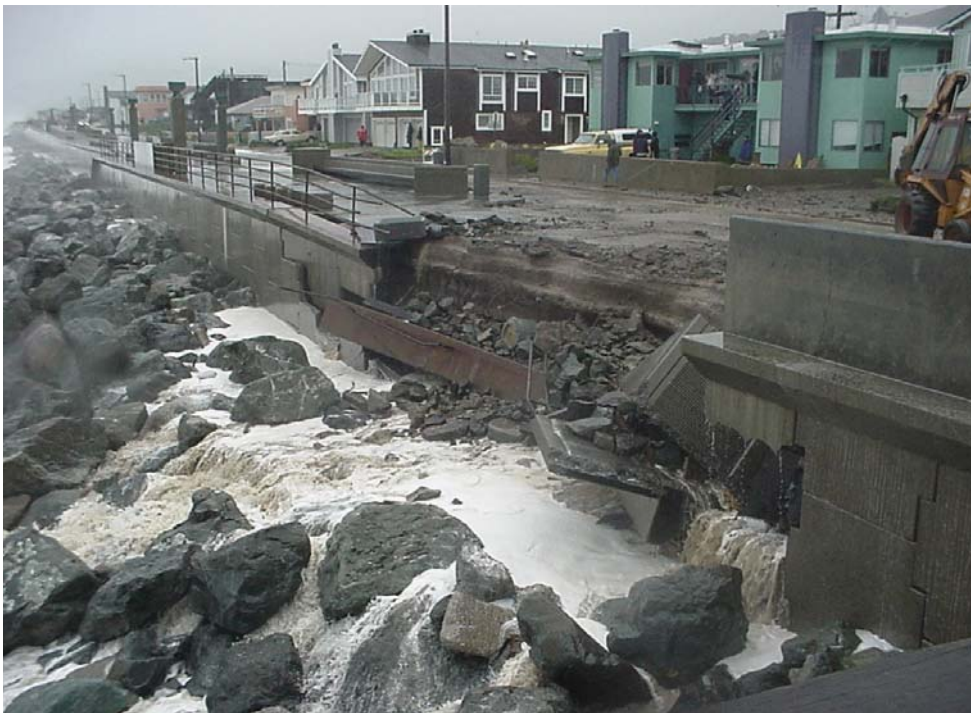
(c) Structural failure of Sharp Park Seawall during January 11, 2001 event

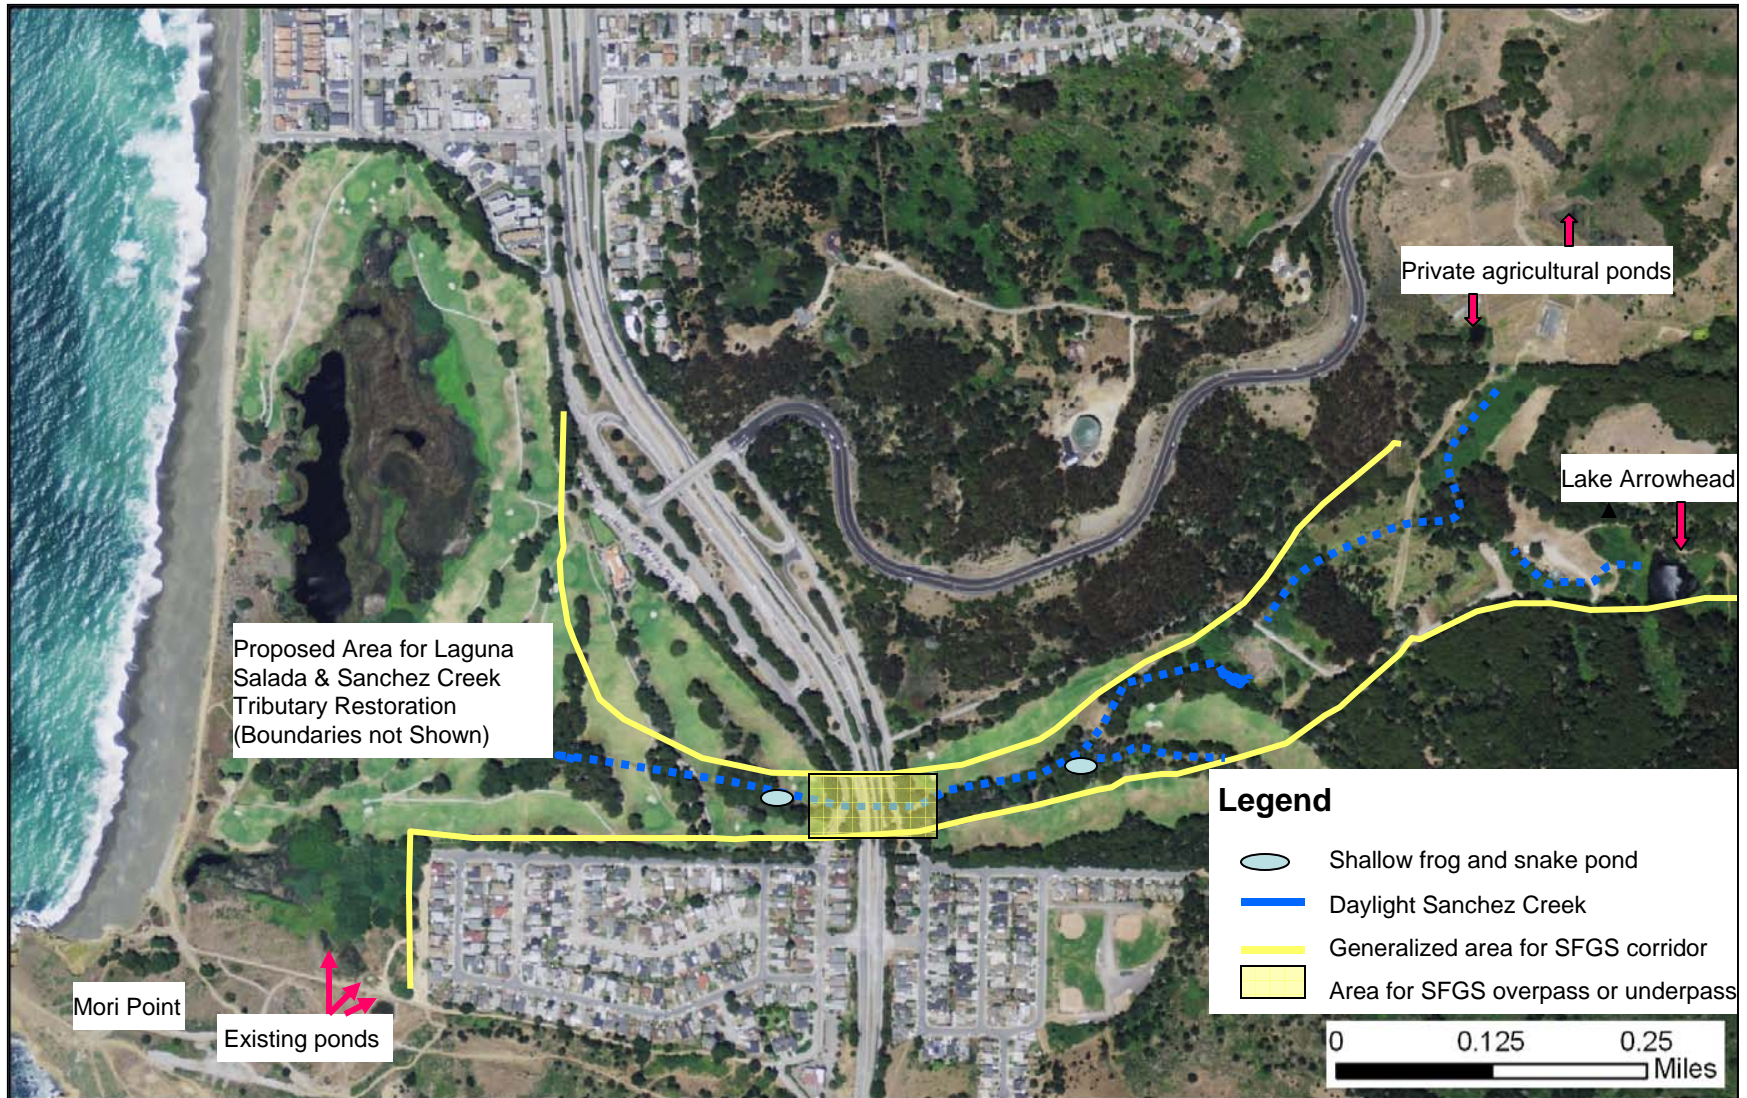
Figure 9. Dedicated area along Sanchez Creek for future restoration of a San Francisco Garter Snake movement into and out of the Lagoon at Sharp Park and Mori Point to Lake Arrowhead east of HWY1, with a land bridge, either under or over HWY and roadways.

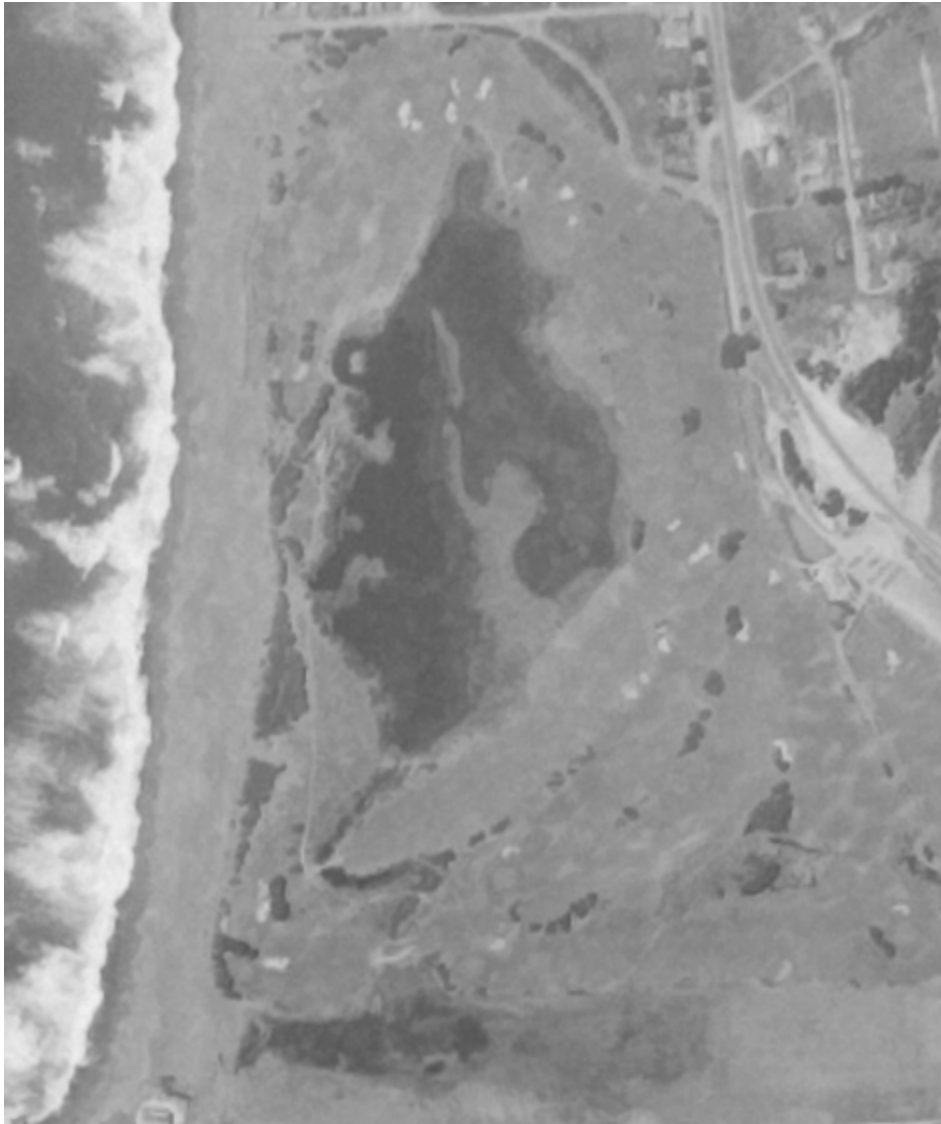
Figure A-1. July 1946 aerial photo enlargement of Laguna Salada,. U.S. Geological Survey Aerial Photo (B&W) 7-29-1946. The beach and foredune zone includes dark grey irregular, continuous woody vegetation, likely Monterey cypress remnants evident in 1930s ground photos (A) on the landward side of the barrier beach. Traces of lightly shadowed lines in the foredune/backbeach zone are likely locations of sand fences and low ridges of European beachgrass remaining from 1930s plantations. At the north end of the foredunes, unvegetated or very sparsely vegetated sand spreads landward among scattered patches of darker (woody) vegetation, indicators of accreting sand from eolian or low-energy overwash processes. Most of the lagoon bed is mottled dark gray with variable texture, indicating an emergent (drawdown) vegetated condition with relatively little open water habitat. Lagoon fringing marsh vegetation is fresh and fresh-brackish marsh, based on herbarium collections at "marshes at Sharp Park" by Nobs and Smith in August 1949.

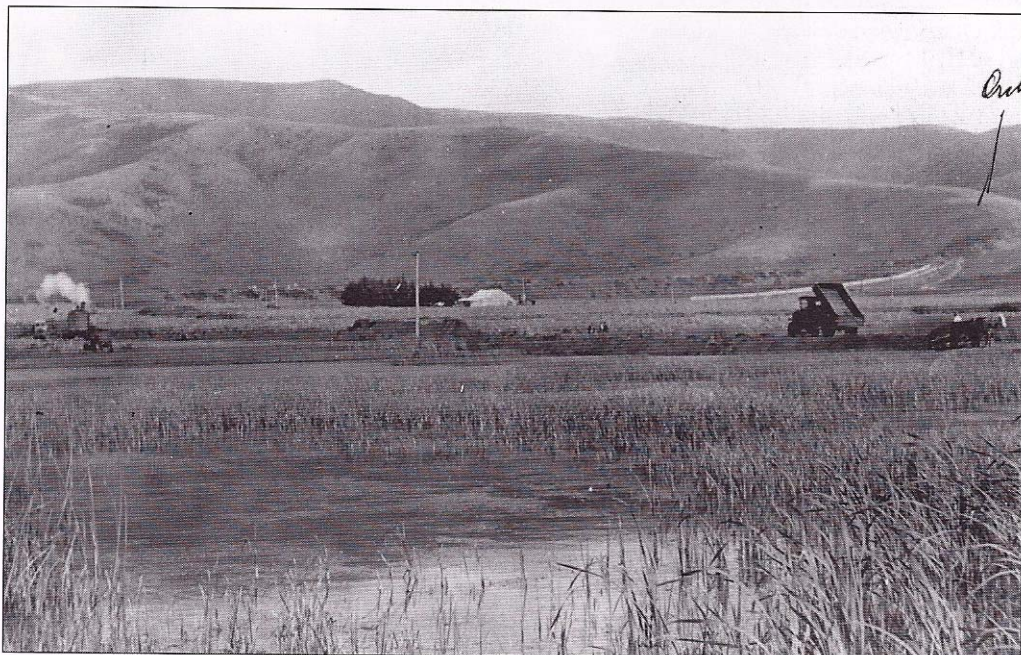
Figure A-1. Late agricultural period (early 20th c, pre-golf) Laguna Salada. View towards east of landward shore of Laguna Salada with highly visible emergent fresh-brackish to brackish marsh vegetation indicators (cattail and bulrush), simultaneous with truck dumping earthen fill (for perimeter road or berm construction) during agricultural land use (cropland shown in background, prior to golf course construction). Undated photo estimated 1920s to early 1930s. The identifiable wetland and aquatic vegetation visible in the foreground includes vigorous, tall cattail with lax broad blades (*Typha* sp, foreground right, green arrow; alkali-bulrush (*Bolboschoenus maritimus*), a few straight rigid stems of tule (*Schoenoplectus californicus* or *S. acutus*), with either sago pondweed (*Stuckenia pectinata*), wigeongrass (*Ruppia maritima*), or both, on water surface. The background emergent grass-like marsh vegetation is not identifiable to species or genus, but is consistent with short or deeply flooded cattail or tall bulrush marsh, such as *S. pungens* (fresh to brackish marsh plant that was collected at Laguna Salada in 1908, long before Sharp Park golf course (Table A-1). This vegetation is inconsistent with salt marsh hydrology and vegetation (shrubby pickleweed or prostrate saltgrass). None of the plant species shown (except *Ruppia*) are tolerant of prolonged high salinity. The fresh-brackish marsh species inferred were subsequently vouchered by herbarium specimens from Sharp Park/Laguna Salada marshes in 1949, and are still present in modern fresh-brackish Laguna Salada marshes. All species shown are typical of fresh-brackish coastal marshes inhabited by California red-legged frogs in coastal San Mateo County today.

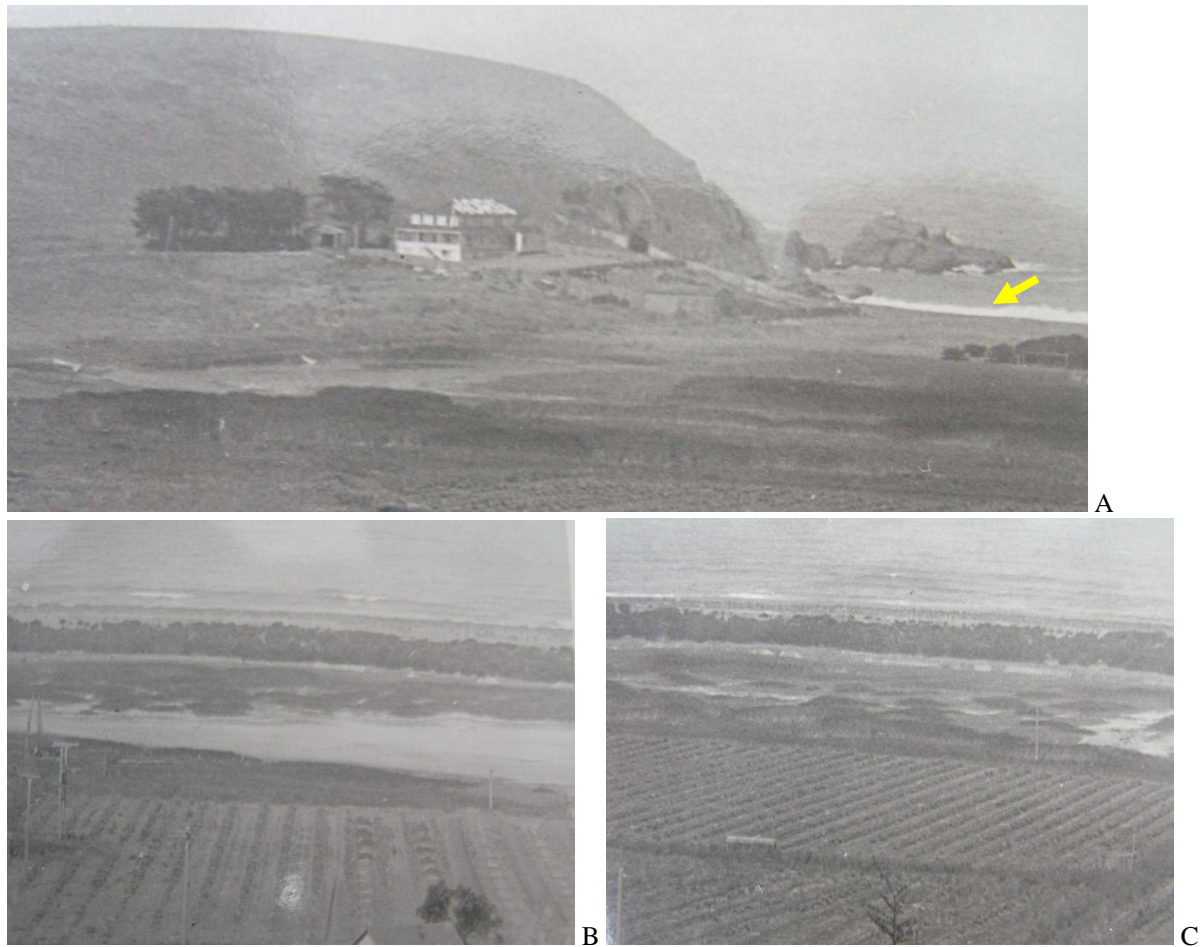
Figure A-3. Late agricultural period (early 20th c) Laguna Salada, enlarged cropped views of Laguna Salada to southwest from hillslopes above. Photograph undated, but taken after establishment of nearly closed-cover cypress plantation on beach; likely circa late 1920s, but prior to installation of electrical utility poles to the end of the flume below Mori Point (shown in Fig. A-2). Emergent (drained) unvegetated lagoon flats and emergent marsh vegetation are evident in the lagoon. Row crops (likely artichoke) occupy the lagoon valley floodplain, indicating land use dependent on drainage or low lagoon levels. An unvegetated emergent flat to gently sloping sandy gap in the cypress on barrier beach occurs at the extreme south end of the lagoon (yellow arrow, A), consistent with location washover sedimentation over a breach (potential lagoon outlet position). Dark vegetation on barrier beach corresponds with Monterey cypress plantation in other early 20th c photos. Vegetation structure and pattern on lagoon flats is consistent with bulrush, cattail, tule (tall emergent grass-like morphology and clonal growth) and incomplete colonization of lagoon flats. Photo courtesy of private collection.

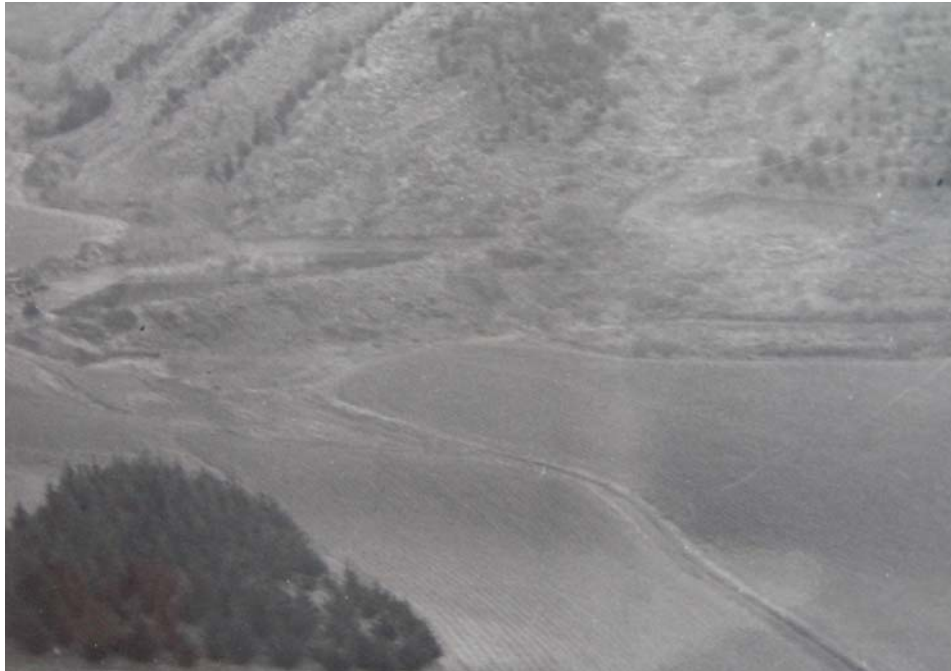
Figure A-6 . Impoundment, likely an irrigation reservoir, near toe of hillslope above Laguna Salada, with ditch (center) and vegetated channel (right, center) downslope. Photography likely late 1920s, early 1930s, annotated “Sharp Park”. Courtesy of private archive.

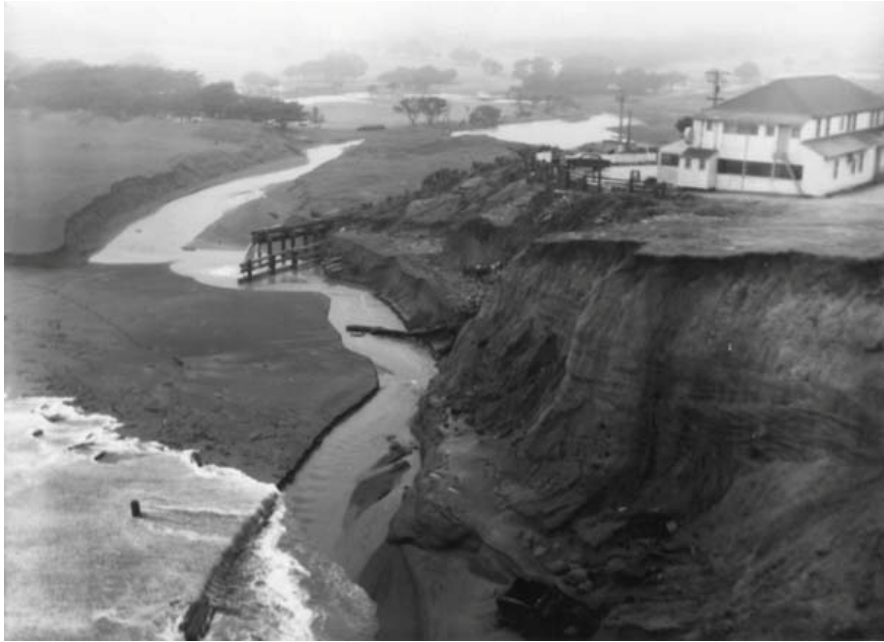
Figure A-8 . Mori Point outlet draining remnant of Laguna Salada at Sharp Park Golf Course, reported date 1966. The shallow channel bed is incised in the beach above the elevation of the swash, with a swash bar forming below the mouth of the outlet. Not tidal inlet morphology is evident. Photo courtesy of private collection.

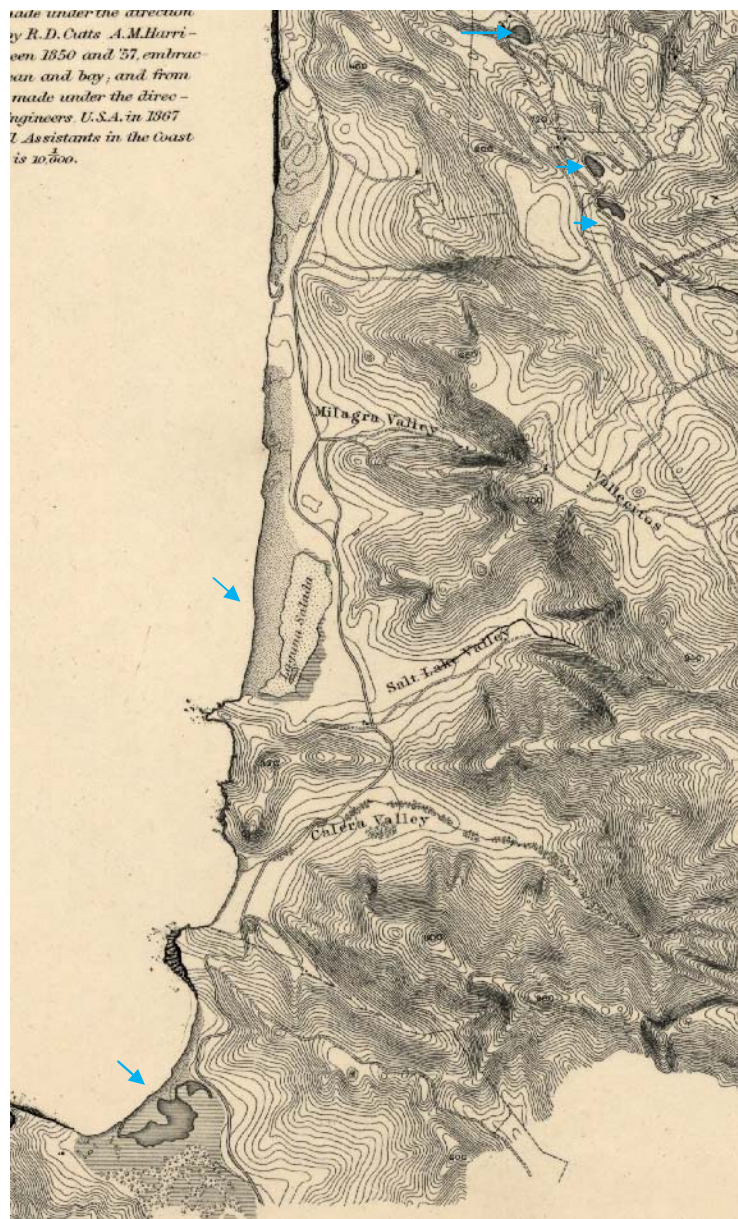
Figure A-10. Excerpt from the 1869 U.S. Coast Survey map of the San Francisco peninsula, showing distribution of naturally impounded waterbodies (lagoons, ponds shown in blue arrows) along the outer coast and in the lee of the first coastal ridge (Pacific coast watersheds). Shown are fault-controlled ridgetop Skyline sag ponds, backbarrier lagoons at Laguna Salada and San Pedro Creek mouth. Riparian vegetation is shown discontinuously distributed along Calera Creek (Calera Valley); no riparian vegetation is shown in the creek of Salt Lake Valley (Laguna Salada watershed), which terminates before reaching the lower valley.

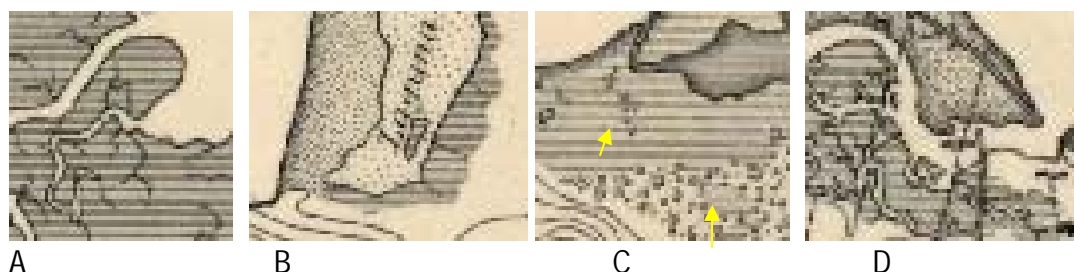
Figure A-13. Comparison among marsh representations in 1869 U.S. Coast Survey map of San Francisco Peninsula. San Bruno tidal salt marsh (A), Laguna Salada landward fringing marsh (B), San Pedro Creek mouth lagoon (C; see also full view, Figure A-14), mouth of San Francisco Presidio Marsh, with possible impoundments (now near modern Crissy Field; D). Tidal salt marshes at San Bruno and Presidio (A, D) are shown with open tidal channel connections to the bay or Golden Gate, and exhibit sinuous, dendritic channel patterns, with no inclusions of woodland vegetation symbols within tidal marshes mapped by horizontal hatching – a general feature of San Francisco Bay T-sheet representation of tidal salt marsh. The horizontal hatching marsh symbol is also applied to San Pedro Creek lagoon mouth marsh near the outlet, where it includes island-like “strings” of (salt-intolerant) riparian scrub, and borders extensive riparian scrub within the creek floodplain. The same hatching symbol is also applied to southeastern Laguna Salada marsh (B, and Figure A-11) with non-sinuuous channels oriented in a pattern consistent with relict stream mouth delta drainage and a marsh-capped delta shield islet. The use of this symbol in contrasting salinity settings (compare Figure A-14) indicates a wide range of coastal marsh vegetation, hydrologic settings on the region (fresh, brackish, saline) to which it was applied at the time.

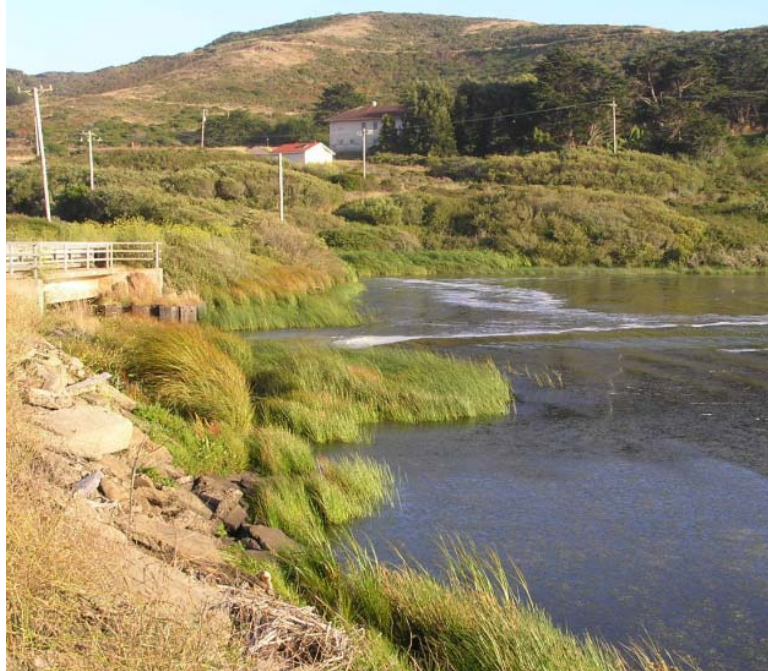
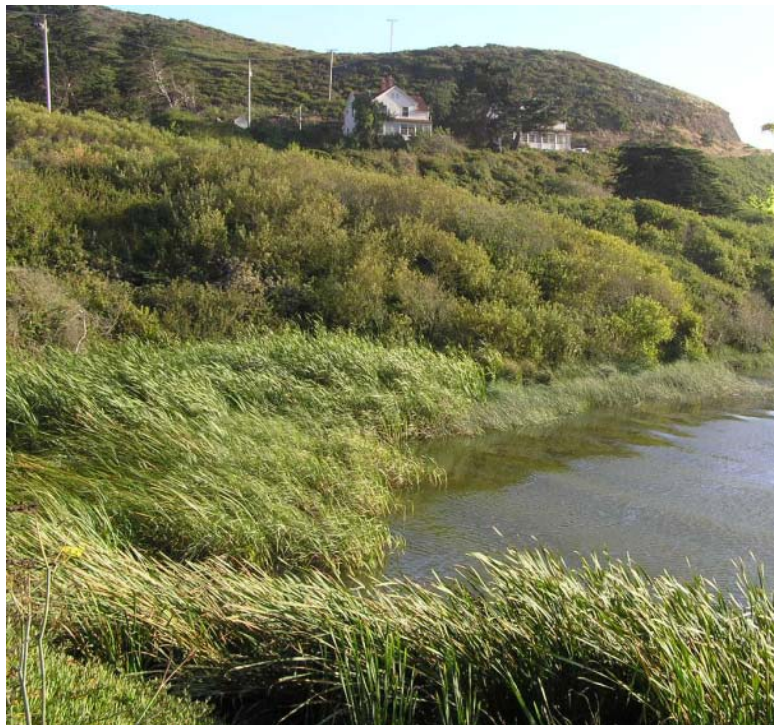
Figure A-18 . Head of Rodeo Lagoon, Marin County, a predominantly non-tidal brackish lagoon grading to fresh-brackish marsh at its landward end, despite partial isolation from its freshwater stream delta. The head of the modern lagoon is here dominated by threesquare bulrush, cattail, spikerush, with slough sedge, typical of fresh-brackish coastal marsh; the adjacent vegetated shallows are dominated by submerged sago pondweed. This marsh is cut off from the freshwater former head of Rodeo Lagoon and the delta of Rodeo Creek, which now form a freshwater marsh above (left of) the road and culvert shown. The seaward end of the lagoon supports more brackish-saline wetlands dominated by alkali-bulrush, saltgrass, salt rush, pickleweed, jaumea, and threesquare bulrush, with wigeongrass replacing sago pondweed as the dominant submerged aquatic vegetation.

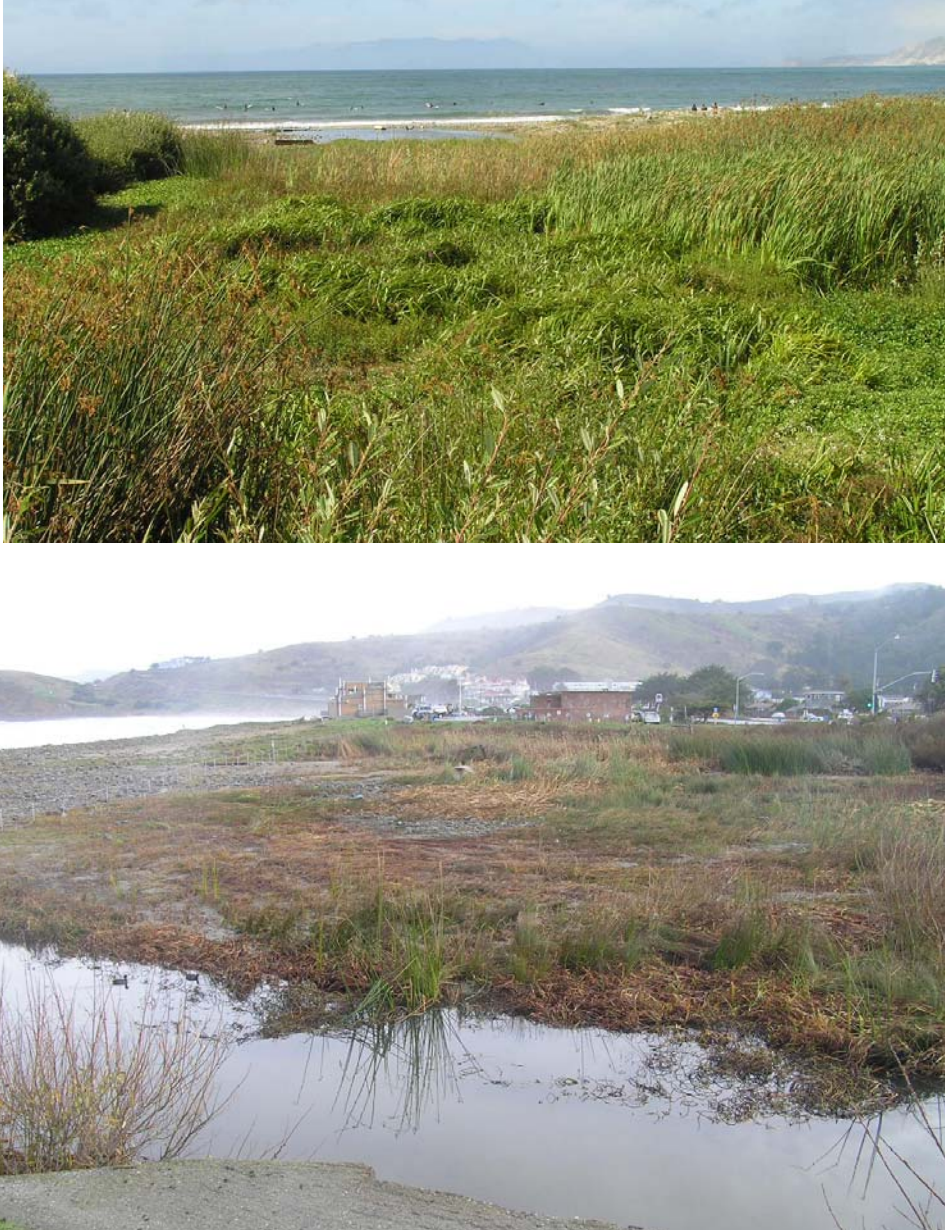
Figure A-19. Modern San Pedro Creek mouth lagoon, Pedro Point, Pacifica in 2008-2009, showing freshwater marsh established directly behind the low barrier beach (A) with an open stream outlet subject to infrequent winter overwash (B). Fresh-brackish and freshwater marsh regenerate annually at the seaward edge of the marsh, and perennial freshwater marsh (bulrush, tule, cattail dominants) is maintained in the low-flow summer season by partial impoundment of the mouth by a low cobble and sand beach berm. The lagoon was excavated as part of the San Pedro Creek flood control and stream restoration project, completed before 2004. California red-legged frog adults and adult terrestrial garter snakes (subspecies similar to the rare San Francisco garter snake) have been confirmed present in the lagoon and its immediate vicinity.

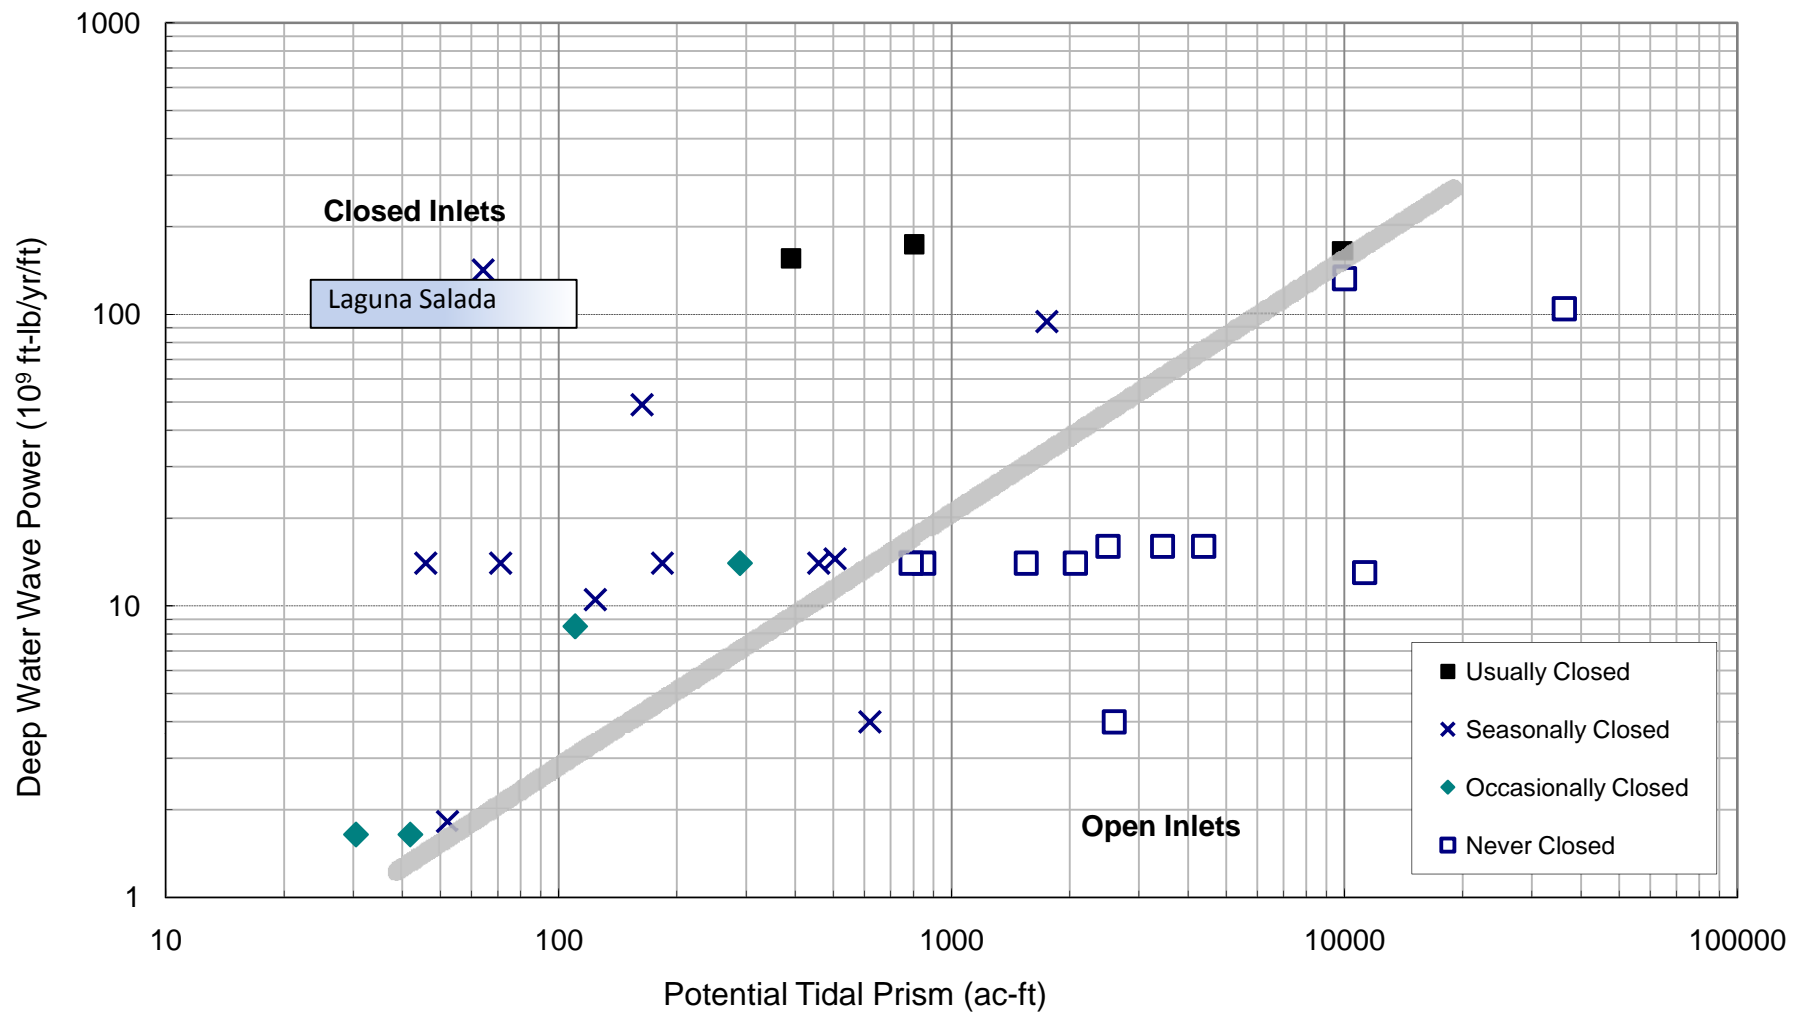
Notes: Laguna Salada nearshore wave power = 95-140 x 10⁹ ft-lb/yr/ft.
Existing potential tidal prism = 24 ac-ft.
Estimate of maximum historic potential tidal prism = 115 ac-ft (assumes intertidal footprint of 20 acres).

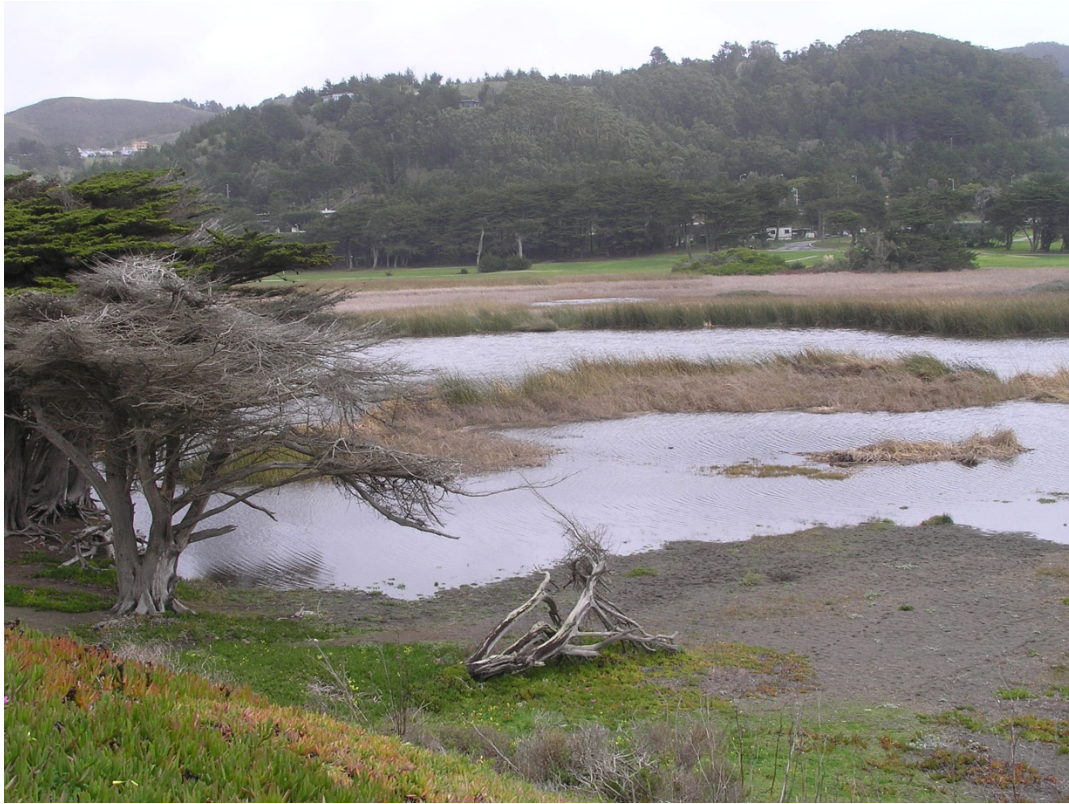
Figure 1. **Artificially low maximum water levels of Laguna Salada.** Central western shore of Laguna Salada at remnant washover fan following winter rains (February 17, 2009), showing transient lagoon surface elevations re-occupying artificially drained floodplains above emergent tule marsh prior to drainage by pumps. Rapid drawdown due to pumping prevents seasonal wetland habitats from establishing in upper flooded areas.

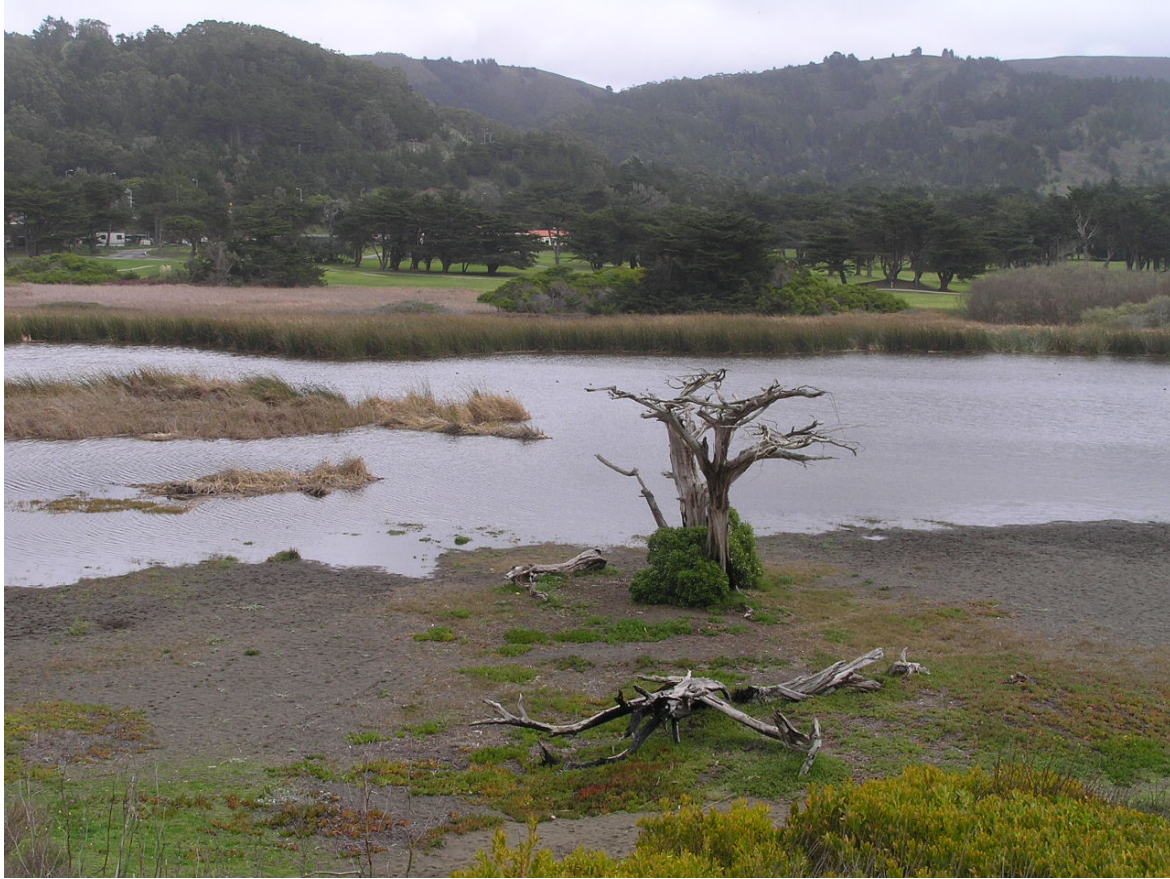
Figure 2. **Artificially low maximum water levels of Laguna Salada.** Central western shore of Laguna Salada at remnant washover fan following winter rains (February 17, 2009), showing temporary lagoon surface elevations partially re-occupying artificially drained floodplains prior to drainage by pumps. Rapid drawdown due to pumping prevents seasonal wetland habitats from establishing in upper flooded areas.
