Over the last 18 months, an independent team of scientists and engineers with expertise in coastal restoration has worked to prepare the attached report on Sharp Park, *Conceptual Ecosystem Restoration Plan and Feasibility Assessment: Laguna Salada, Pacifica, California*.

Prepared for:

Wild Equity Institute
Center for Biological Diversity

ESA PWA

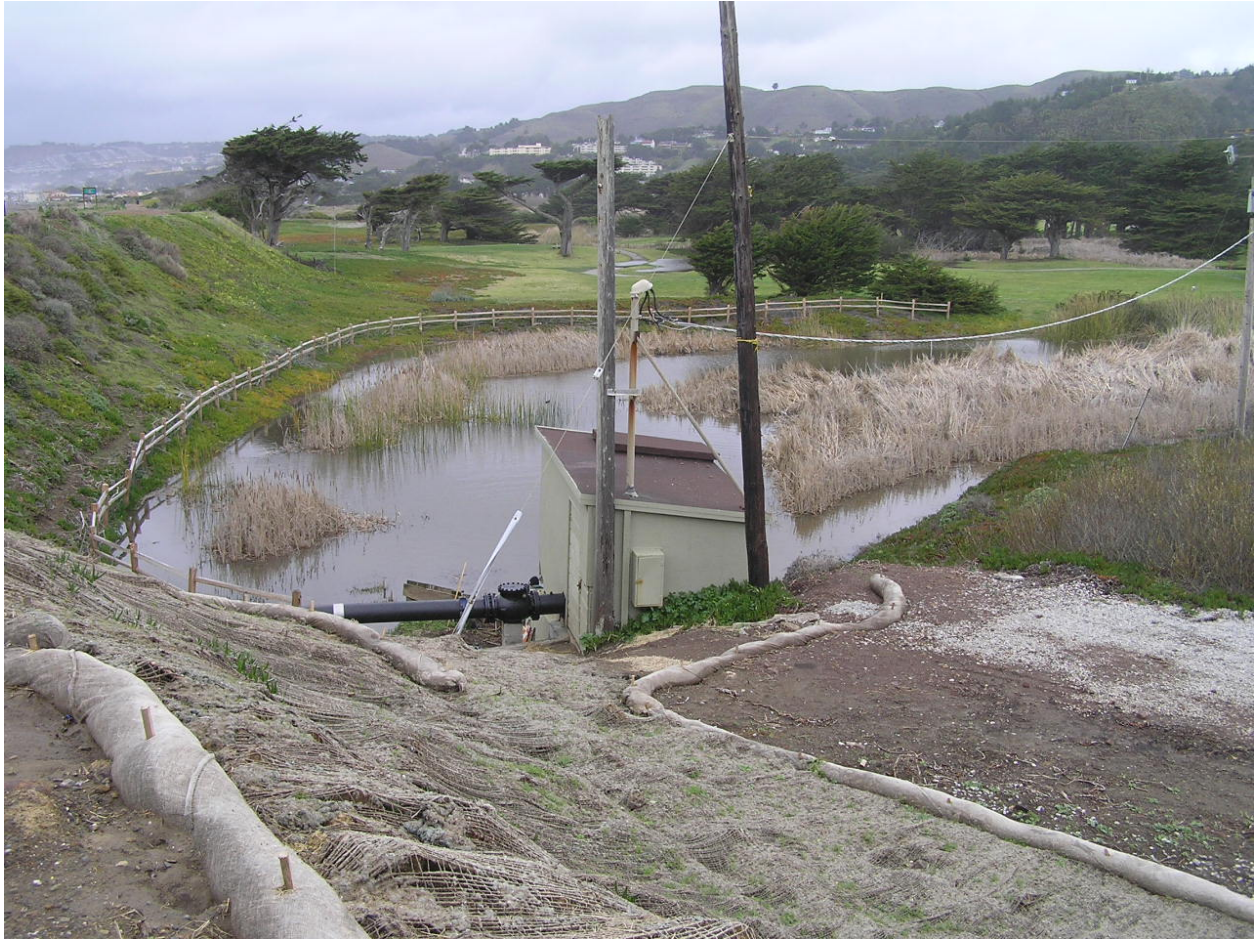
Figure 3. **Artificially low maximum water levels of Laguna Salada.** Horse Stable Pond at pump station, showing transient high lagoon surface elevations partially re-occupying artificially drained floodplains, February 17, 2009. Note partial flooding of fairways in background. Rapid drawdown due to pumping prevents seasonal wetland habitats from establishing in floodplain above tule marsh.

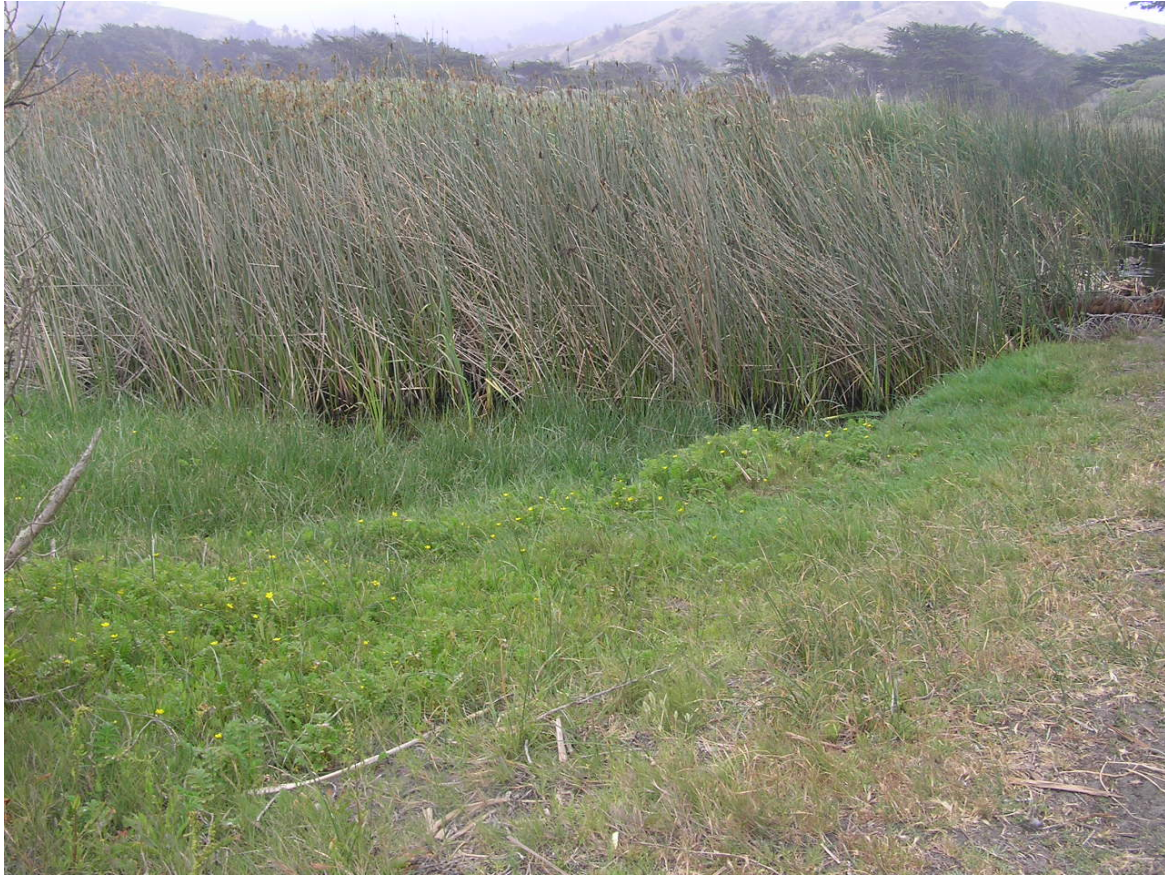
Figure 4. **Artificially low water levels of Laguna Salada and marsh zonation.** Fresh-brackish tule marsh (*Schoenoplectus californicus*) of central west shore Laguna Salada is drained in late spring of dry year (June 15, 2009) nearly to base of tule culms; tule marsh elevations colonized by perennial stands of less flood-tolerant threesquare bulrush (*Schoenoplectus pungens*). Corresponding marsh zones in natural seasonal or nontidal lagoons of the Central Coast are submerged in spring.

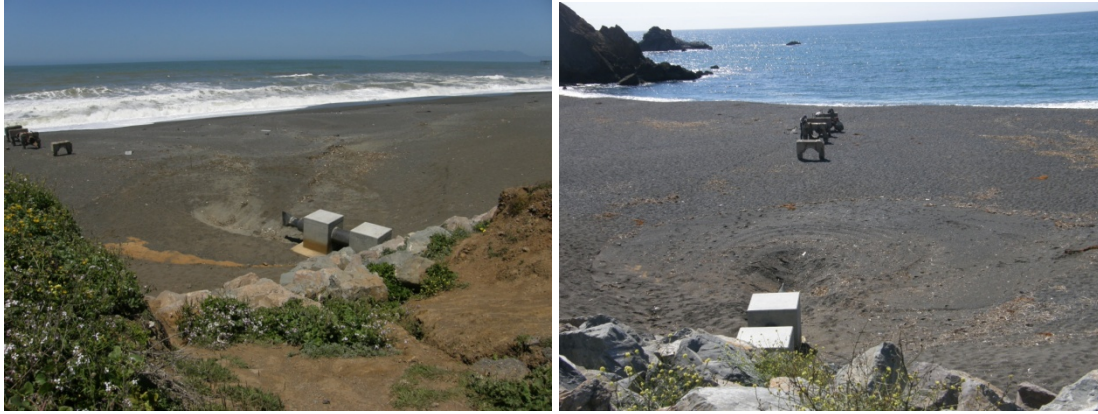
Figure 5. **Drainage and discharge of Laguna Salada waters on Salada Beach during the dry season.** The natural filling of Laguna Salada by Sanchez Creek low flows and groundwater discharges in summer is arrested by active pumping even in dry months, maintaining artificial drawdown of the lagoon to low levels all year. Discharge point below the outfall results in scour pools, internal drift-lines delineating high water levels in the pool, and an erosional discharge channel. Photo at left June 11, 2010. Right, August 17, 2010.

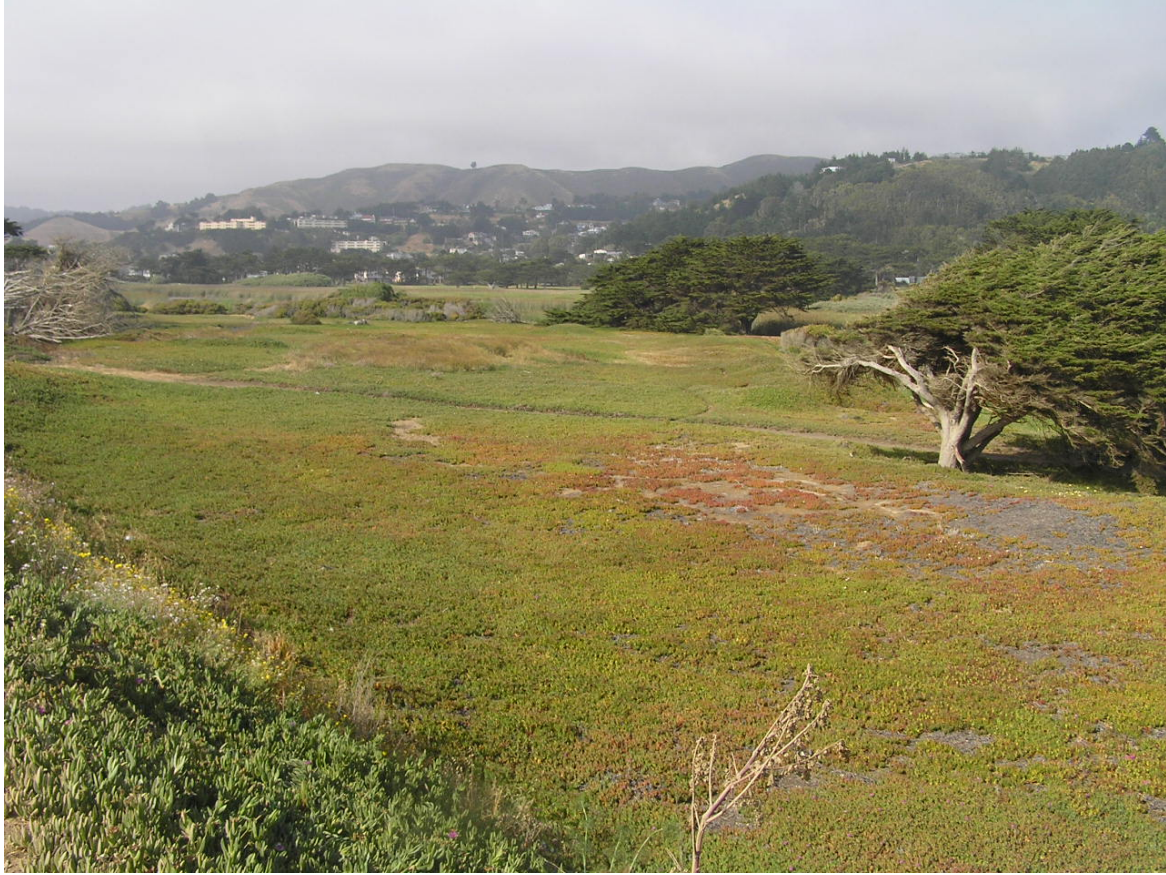
Figure 6. **Relict washover flats: drained lagoon floodplain and upland ecotone vegetation invaded by non-native species.** Remnant washover flats landward of “seawall”, dominated by non-native terrestrial vegetation. Iceplant (*Carpobrotus edulis* x *chilensis*) occupies the (artificially drained) potential ecotone between seasonal wetland zones of the lagoon (saltgrass-salt rush -bulrush-silverweed) and native dune vegetation. Traces of native dune vegetation are present but scarce.

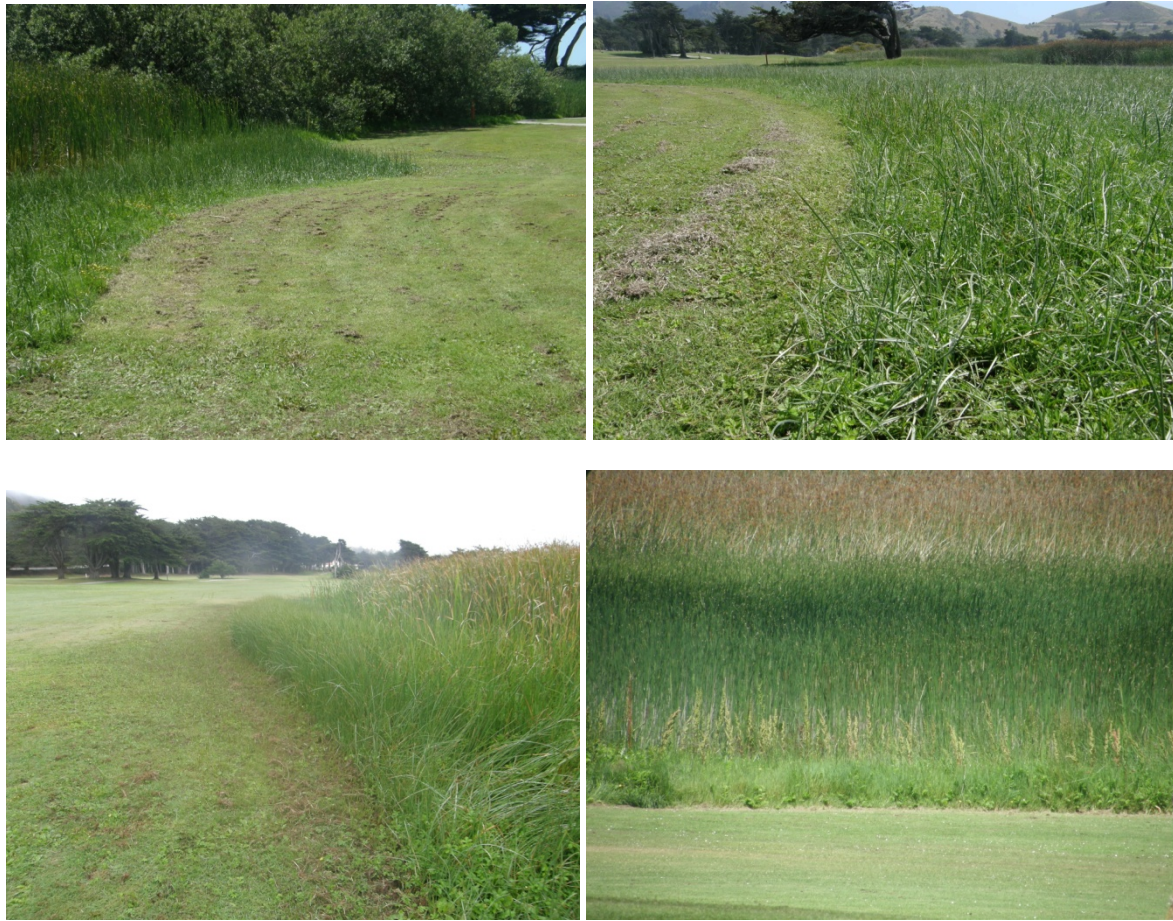
Figure 7. **Marsh mowing: golf maintenance impacts.** The golf turf mowing encroaching the northeast end of Laguna Salada, extending directly into the marsh and riparian woodland zones. The apparent golf turf is composed of the same fresh-brackish marsh species shown at the left, *Schoenoplectus pungens*, *Argentina egedii*, *Agrostis stolonifera*, and *Cotula coronopifolia*. The seasonally flooded outer marsh and its terrestrial ecotone are replaced by turf even with pumped drawdown of the lagoon. The natural floodplain (unimpaired maximum lagoon elevations) would include a much wider floodplain area. All wildlife cover is eliminated, exposing travel corridors of SF Garter snakes and eliminating suitable mammal burrow foraging habitats. All potential buffers for fertilizer impacts are eliminated by encroachment of golf turf into the marsh. Above: June 10, 2010. Below: August 3, 2010.

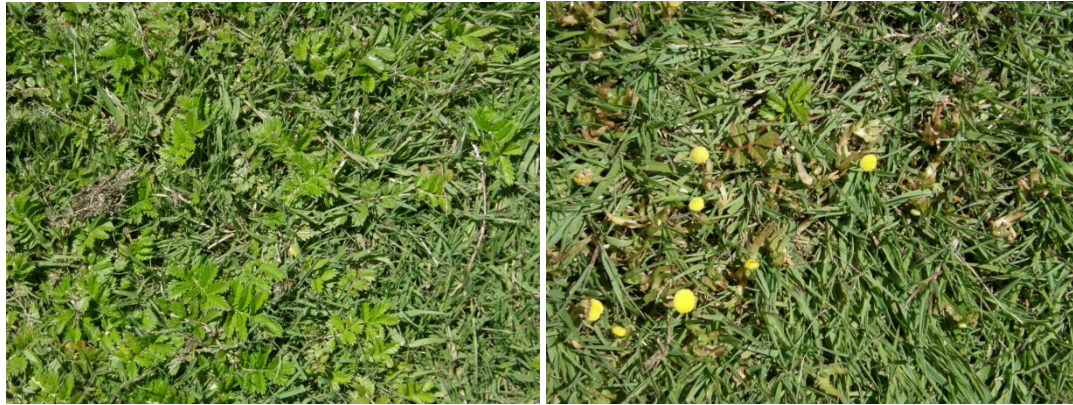
Figure 8. **Marsh mowing: golf maintenance impacts.** Detail of mown marsh turf composition by fresh-brackish marsh (FACW and OBL wetland indicator species): left, *Argentina egedii* (syn. *Potentilla anserina*) and *Agrostis stolonifera*. right, *Cotula coronopifolia* (succulent leaves, yellow flowerheads) and *Agrostis stolonifera*.

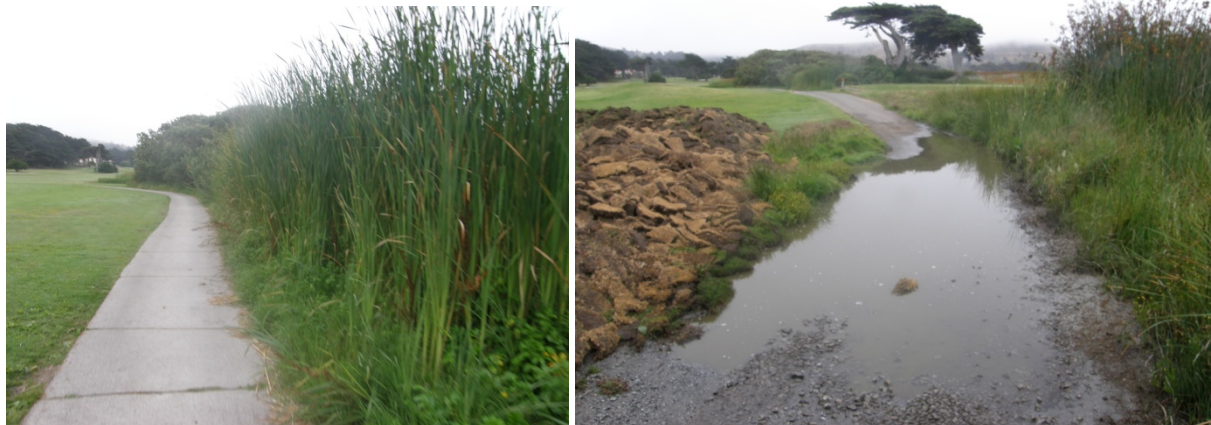
Figure 9. **Marsh mowing: golf maintenance impacts.** Paved path encroachment of fresh-brackish marsh and riparian woodland. Paved paths were constructed in marsh (mown into turf on landward side), and are partially flooded even in the dry season. Earthen fill (golf turf sod wastes) are dumped directly in jurisdictional wetlands (apparently without federal or state authorization) on the landward side of the flooded path at the northeast end of Laguna Salada. August 3, 2010.

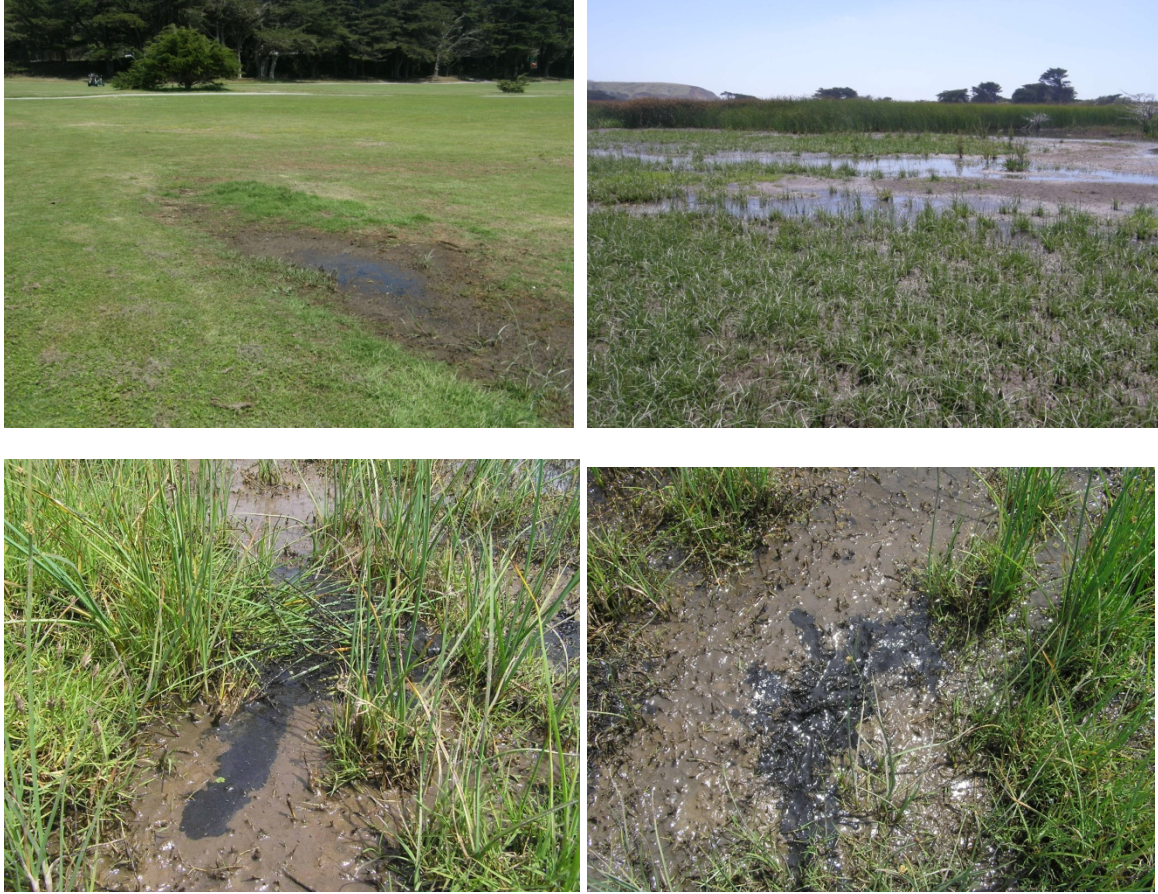
Figure 10. **Iron oxide surface films and iron sulfide accumulation of muds exposed by artificial lagoon drawdown.** Iron oxide (orange-brown mineral films indicative of oxidation of iron sulfide and acid sulfates in brackish coastal sediments subject to alternating strong hypoxia and oxidation) are apparent in drawdown-emergent muds at the northeast end of Laguna Salada. Organic-rich sediment immediately below the iron oxide-stained surface sediment film is deep black (lower left), indicative of toxic iron sulfide, formed under strong hypoxic bottom conditions, exposed at the marsh surface by artificial drawdown of the lagoon.

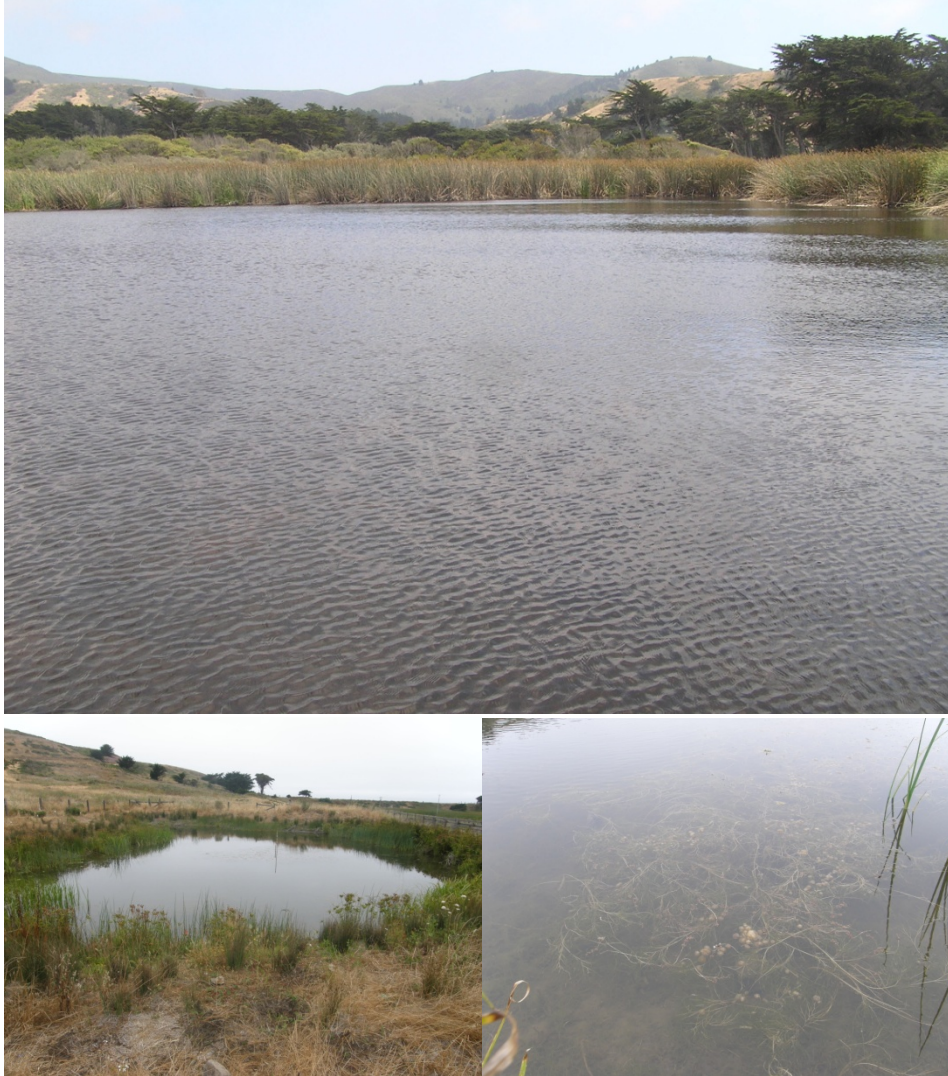
Figure 11. **Absence of submerged aquatic vegetation in modern Laguna Salada contrasting with rapid colonization of adjacent Mori Point perennial ponds.** The wind-rippled surface of the entire Laguna Salada lagoon (above) indicates a lack of submerged aquatic vegetation. The lagoon supported two species of submerged aquatic vegetation (sago pondweed, *Potamogeton pectinata*, syn. *Stuckenia pectinatus*; and wigeongrass, *Ruppia maritima*) in the 20th century and likely before. In contrast, 2 year old ponds constructed by GGNRA adjacent to the lagoon (below) were rapidly colonized by vigorous *Stuckenia pectinatus* in the absence of planting (D. Fong, GGNRA pers. comm. 2010). Sago pondweed is important potential habitat (breeding, foraging) for red-legged frogs, and foraging habitat for waterfowl.

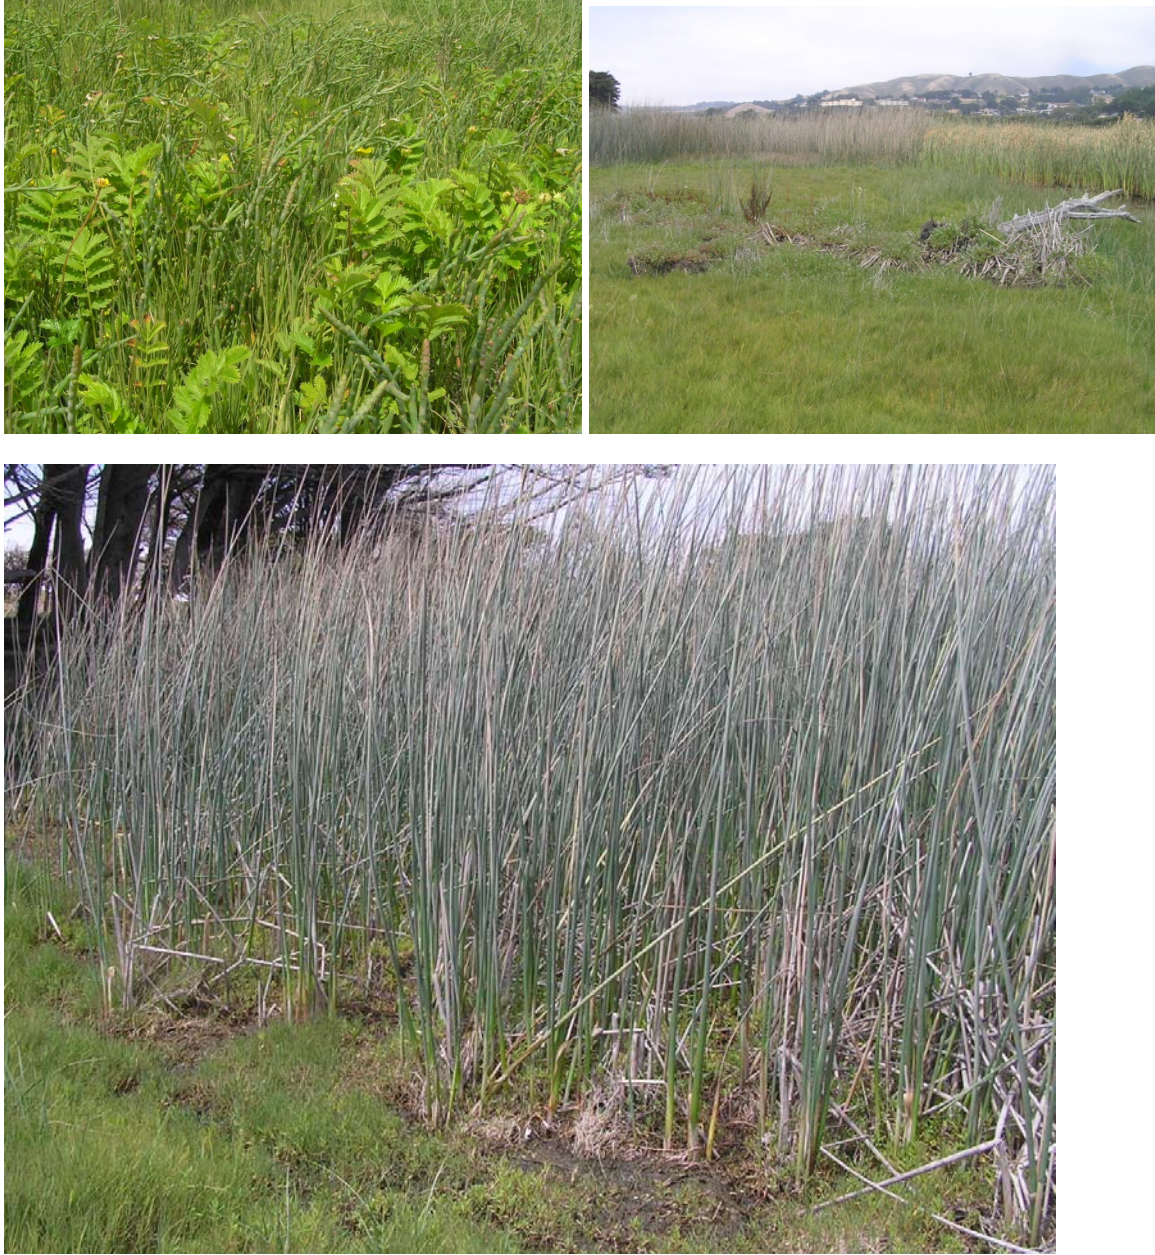
Figure 12 . **Brackish marsh along western shore of Laguna Salada on relict washover fan.** In the absence of overwash in more than 2 decades, brackish and salt marsh plants (pickleweed, saltgrass, jaumea, silverweed; upper left) dominate wetland flats bordering the west shore of the lagoon (upper right), near areas where groundwater salinity has been measured at 15 ppt (nearly half seawater concentration; Kamman 2009). Below, brackish marsh vegetation (saltgrass, jaumea) spreads into ground layer of emergent lagoon bed in summer where hardstem tule dieback has allowed enough sunlight to penetrate.

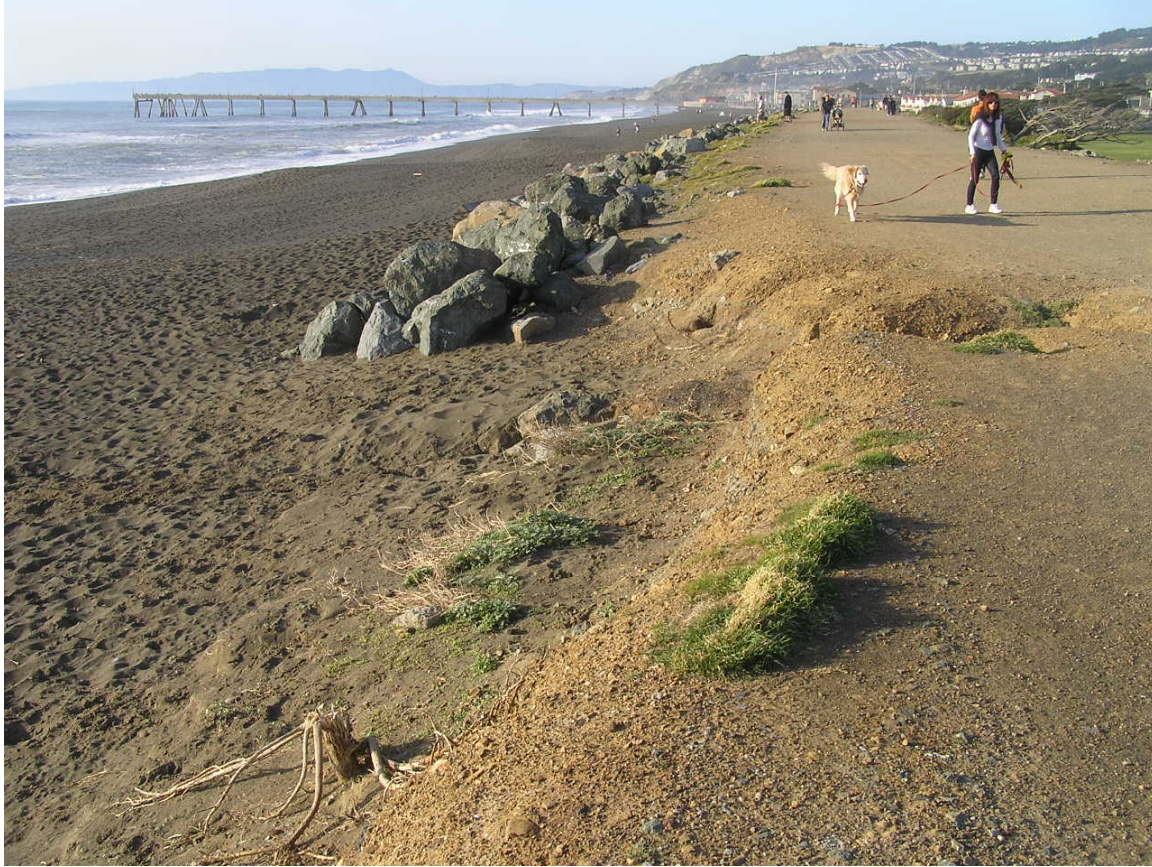
Figure 13. **Armored and earthen “seawall” profiles.** Erosional scarp in earthen berm “seawall” at south end of boulder armoring. No eolian (wind-deposited) dune sand occurs within or in lee of boulders, or on landward slope of berm. Adjacent beach is coarse sand. Small patches of native dune vegetation (beach-bur, *Ambrosia chamissonis*) occur at the toe of the scarp or boulders.

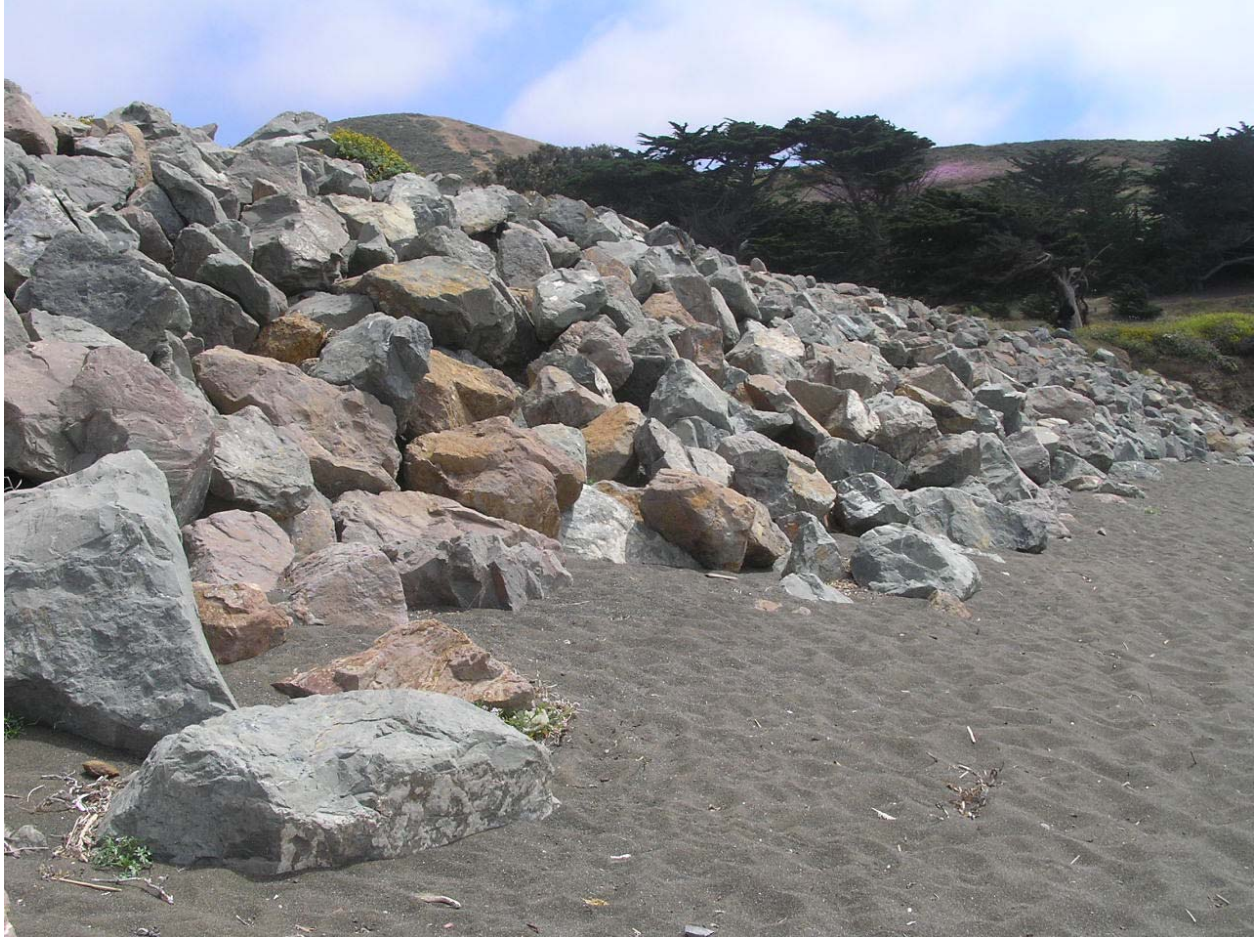
Figure 14. **Beach armoring (boulder revetment).** The historic location of the lagoon outlet, near the modern pump outfall, is completely armored by an engineered boulder revetment approximately 3 m above the adjacent beach. The seawall and revetment preclude natural lagoon outlet from forming and draining impounded floodwaters in Laguna Salada by gravity following natural breaches.

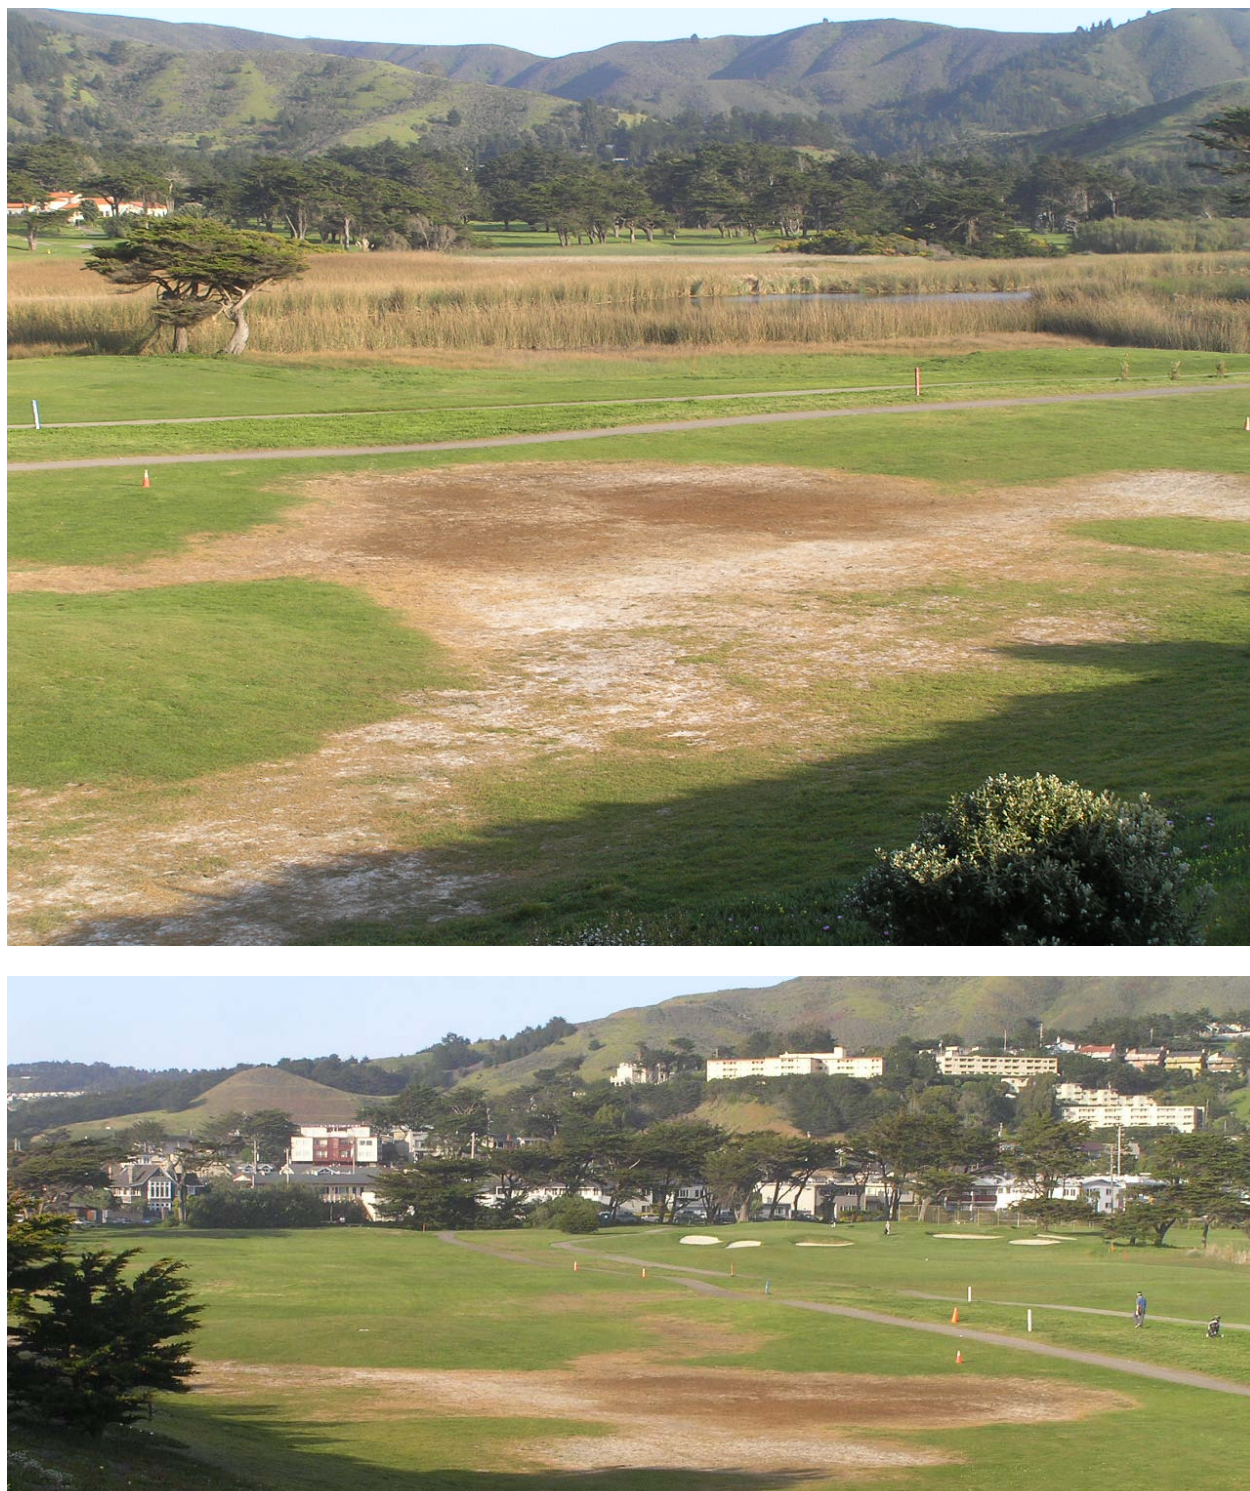
Figure F-1. Overview of saline seep patch in golf turf immediately behind levee at NW end of Sharp Park golf links appeared in February 2010 following high spring tides and high swell runup on adjacent beach, but no levee overtopping

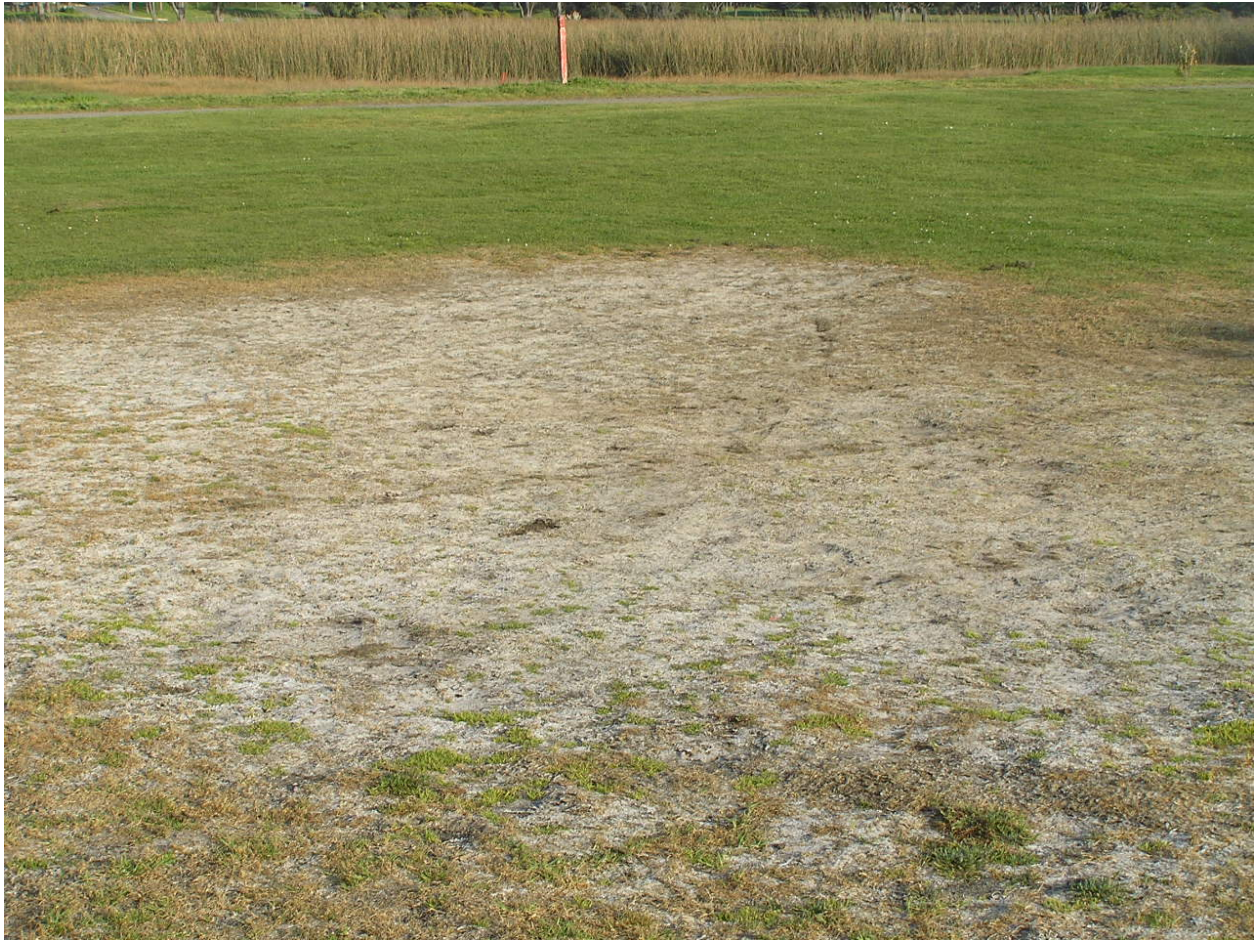
Figure F-2. Conspicuous white salt evaporite film, composed of efflorescent salt crystals deposited by evaporation of capillary soil moisture at soil surface within localized saline seep patches in golf turf immediately behind levee at NW end of Sharp Park golf links. Dead turfgrass litter is covered with efflorescent salt crystal film. Green vegetation within salt-whitened dieback patches is composed of two succulent salt-tolerant weeds *Spergularia* sp. (spurrey) and *Plantago coronopus* (staghorn plantain). No salt spray injury is evident in adjacent green turfgrass; concentrated salt is localized. [Photo: March 27, 2010]

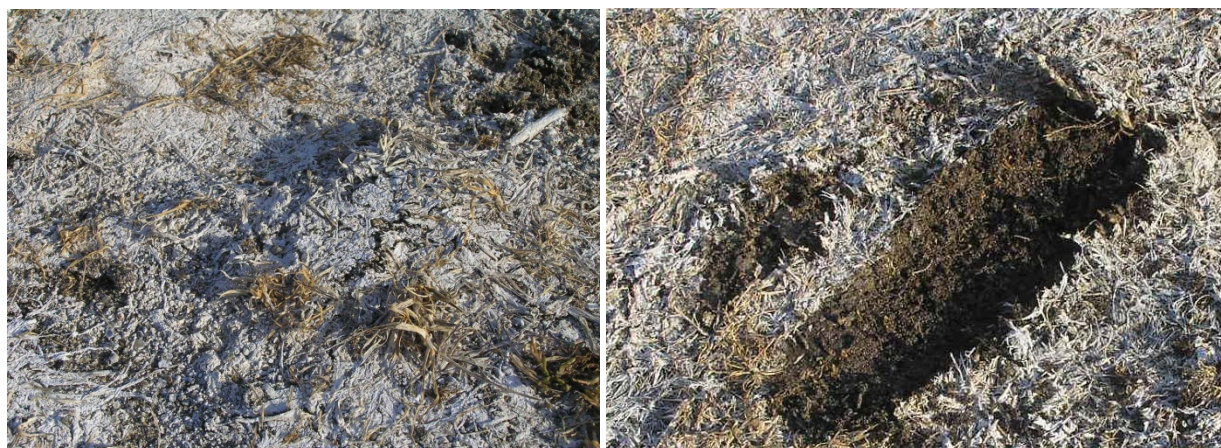
Figure F-3. Surface soil and leaf litter with conspicuous white efflorescent salt evaporite film. Salt crystals deposited by evaporation of capillary soil moisture at soil surface within localized saline seep patches in golf turf immediately behind levee at NW end of Sharp Park golf links. Dead turfgrass and salt-sensitive weed litter is covered with efflorescent salt crystal film. Shallow scrape (right) exposes moist sandy loam (capillary substrate) below white salt crust at surface. [Photo: March 27, 2010]

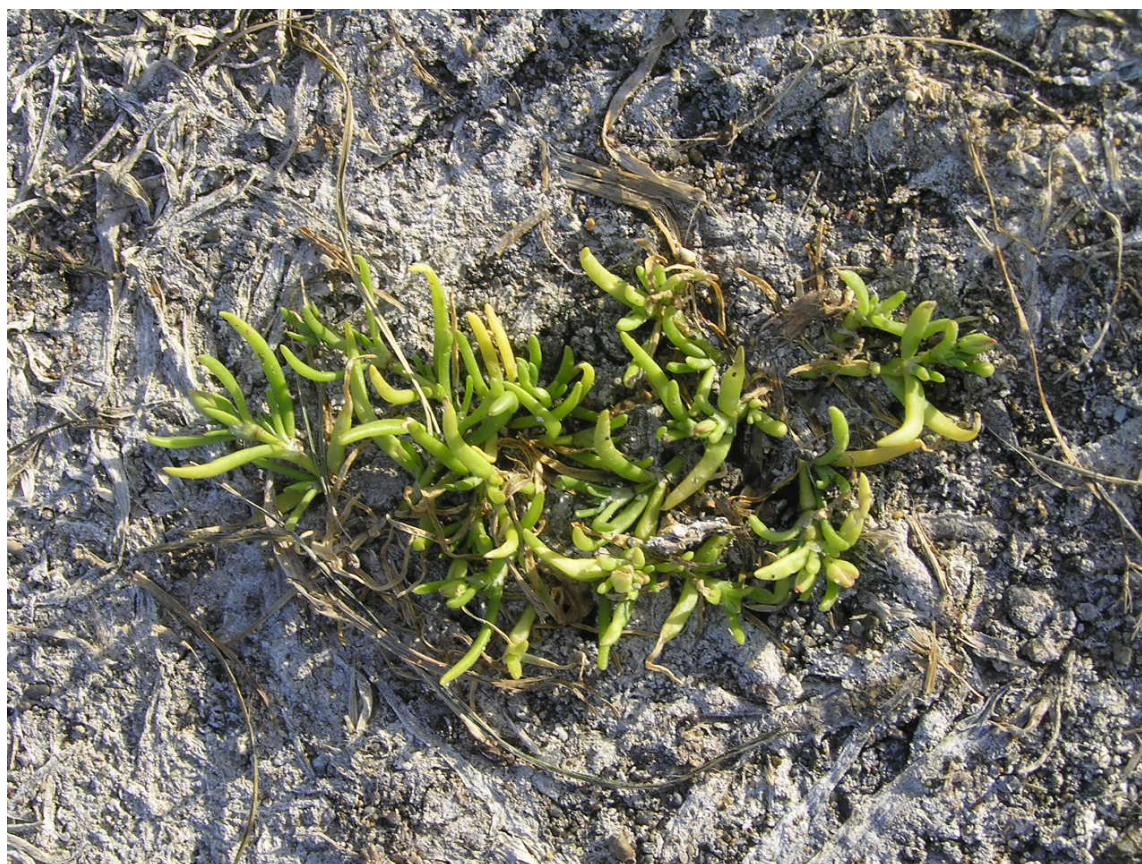
Figure F-4. Detail of succulent salt-tolerant *Spergularia* sp. (vegetative plant, winter) growing in dead golf turfgrass covered with efflorescent salt film deposited by evaporation of capillary soil moisture at temporary saline seep behind levee, NW Sharp Park. [Photo: March 27, 2010]

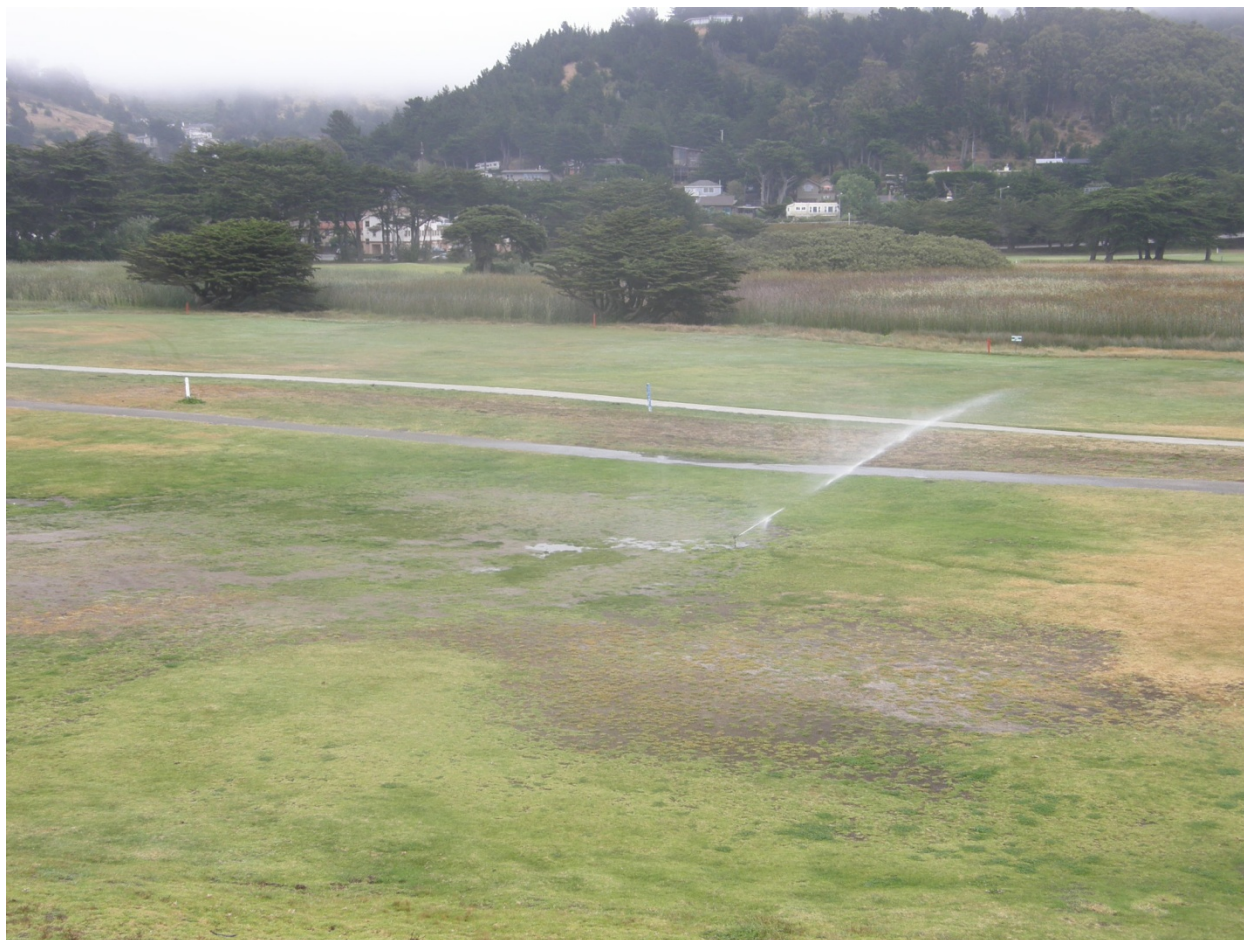
Figure F-5. Sharp Park golf turf dieback patches persist at locations of Feb-Mar 2010 saline seep/capillary evaporate locations (NW golf links), despite overhead irrigation (shown above) that facilitates leaching of soil salts. [Photo: August 3, 2010]

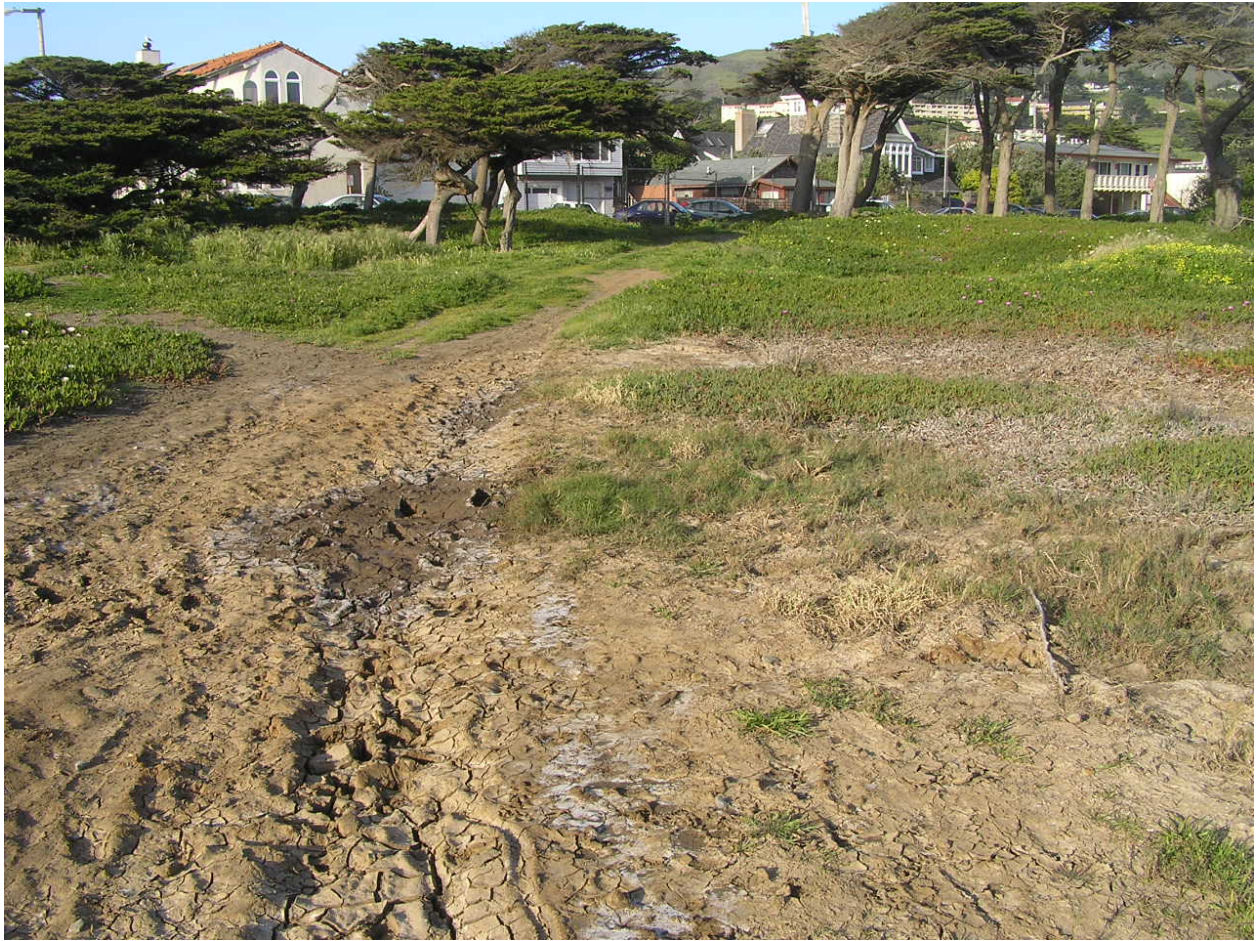
Figure F-6. Local marine flooding of NW corner of Sharp Park golf course from wave overtopping and flooding of Clarendon shoreline gap. Salt evaporite (white film bordering darker saline mud), saltgrass, and dieback patches of iceplant demarcate marine flooding pattern. [Photo: March 27, 2010]

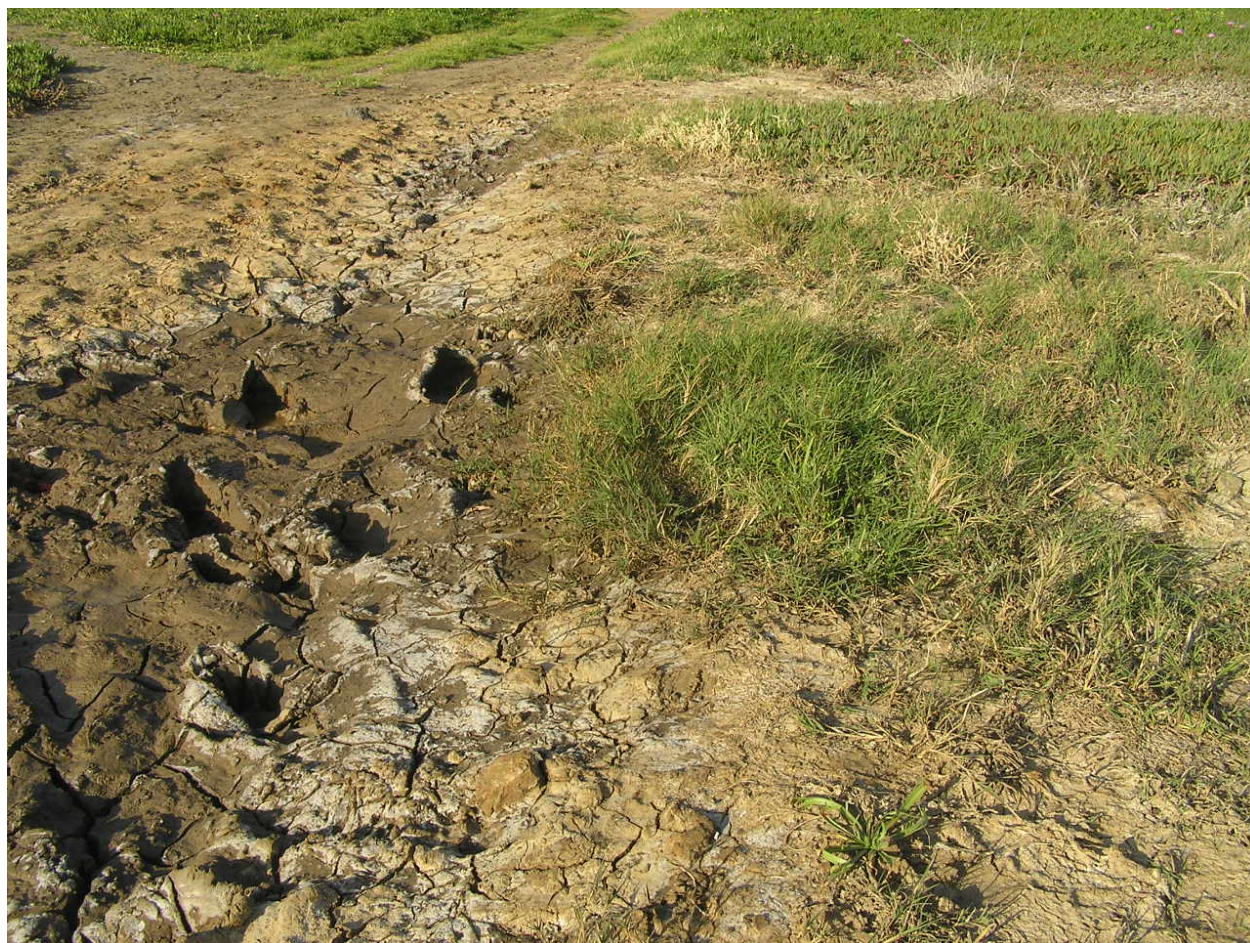
Figure F-7. Local marine flooding of NW corner of Sharp Park golf course from wave overtopping through Clarendon shoreline gap. Detail of evaporated saline puddle with white salt crystal evaporite film and saltgrass; no salt-intolerant species surviving. [Photo: March 27, 2010]
